Access Compliance Report

Public Rights-of-Way

(Curb Ramps)

Intersection ID: 12879	Main Street: HICKORY GROVE RD	Cross Street: N SHARON AMITY RD	Location: E
ADA ID: 35570DF0CA39	Ramp Type: PerpDiag	Initial Pass/Fail: Fail	Overall Compliance: No
Severity Score: 33.75			
Codes/Mitigation Info/Possible Solution		Field Measurements/Component Compliance

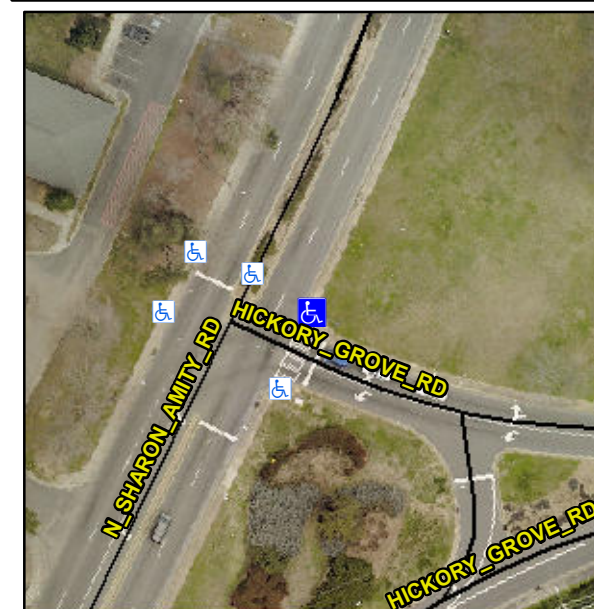
Not Found, R304.5.1, R304.2.2

Compliance	Description	Data	Compliance	Description	Data
N/A	Ramp Length (in)	58.0	No	Ramp Slope (%)	14.6
No	Ramp Width (in)	39.0	Yes	Ramp XSlope (%)	1.6
N/A	Flare Type LT	N/A	N/A	Flare Type RT	N/A
N/A	Flare Slope LT (%)	N/A	N/A	Flare Slope RT (%)	N/A
N/A	Flare Traversable LT?	N/A	N/A	Flare Traversable RT?	N/A
N/A	Landing Length (in)	N/A	N/A	DWS Provided?	N/A
N/A	Landing Width (in)	N/A	N/A	DWS Contrast?	N/A
N/A	Landing Slope (%)	N/A	N/A	DWS Length (in)	N/A
N/A	Landing X Slope (%)	N/A	N/A	DWS Full Width?	N/A
N/A	Landing Curb? (Y/N)	N/A	N/A	DWS Offset (in)	N/A
N/A	Shared Landing?	N/A			
N/A	Gutter Ponding?	N/A	N/A	Gutter Slope (%)	N/A
N/A	Gutter Lip Ht (in)	N/A	N/A	Gutter X Slope (%)	N/A
N/A	Painted X Walk1?	No	N/A	Painted X Walk2?	Yes
	X Walk 1 Direction	To NW		X Walk 2 Direction	To SW
N/A	X Walk 1 Width (in)	N/A	N/A	X Walk 2 Width (in)	112.0
	X Walk 1 Slope (%)	0.4		X Walk 2 Slope (%)	0.2
	X Walk 1 X Slope (%)	0.9		X Walk 2 X Slope (%)	2.6

N/A	Ramp inside XWalk1?	N/A	N/A	Ramp inside XWalk2?	Yes
	Road Slope (%)	0.9	N/A	Clear Space?	N/A
	Road X Slope (%)	2.8	N/A	Clear Space to XWalk (in)	N/A
N/A	Any Obstructions?	N/A	N/A	Storm Grate/Utility Hazard?	N/A
	Obstruction Type			Storm Grate/Utility Type	
		N/A			N/A
			Yes	Surface Condition? (G/P)	Good

Possible Solutions:

Remove & Replace Curb Ramp With Two New Directional Ramps or Equivalent.
