# Access Compliance Report

## Public Rights-of-Way

### (Curb Ramps)

| Intersection ID: 43738 | Main Street: BRIDGEMOUNT_AV | Cross Street: ELIZABETH_MADISON_CT | Location: NW |

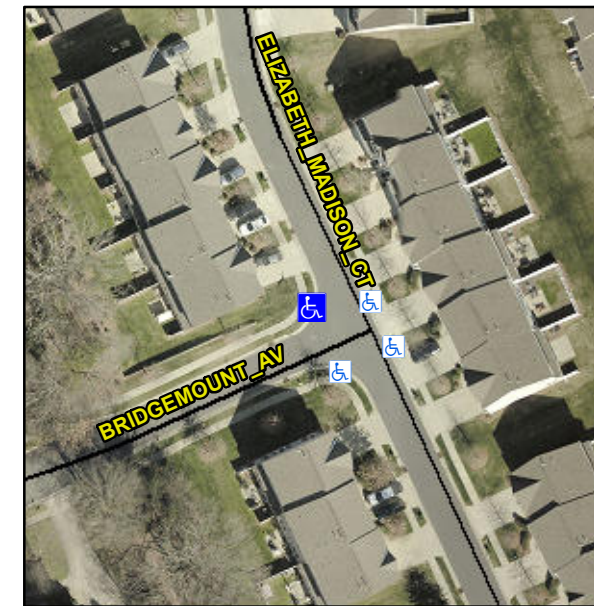
**Not Found, R304.5.1, R304.5.1, R304.5.3, R304.3.2**

**Remove & Replace Curb Ramp With Two New Directional Ramps or Equivalent.**

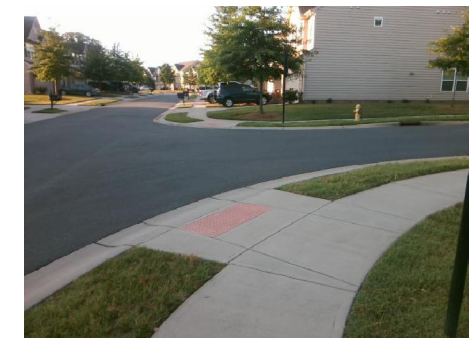
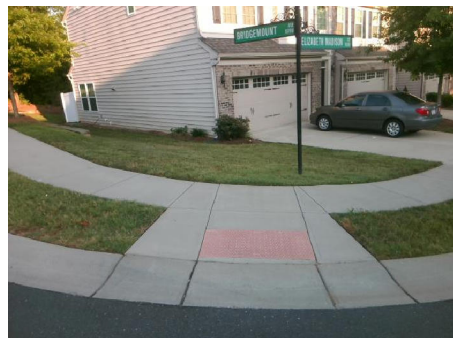
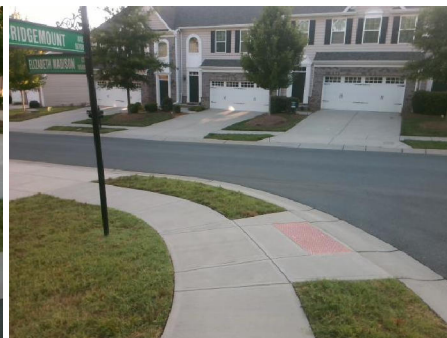
| Compliance | Description | Data | Compliance | Description | Data |
|---|---|---|---|---|---|
| No | Ramp Width LT (in) | 46.0 | No | Ramp Width RT (in) | 47.0 |
| No | Ramp Slope LT (%) | 9.4 | Yes | Ramp Slope RT (%) | 6.6 |
| No | Ramp Width (in) | 47.0 | No | Ramp XSlope (%) | 7.8 |
