# Access Compliance Report

## Public Rights-of-Way

### (Curb Ramps)

Intersection ID: 50475	Main Street: BRONWIN_ST	Cross Street: S_TRYON_ST	Location: NW
ADA ID: 3558641C78D6	Ramp Type: PerpDiag	Initial Pass/Fail: Fail	Overall Compliance: No
			Severity Score: 21.25

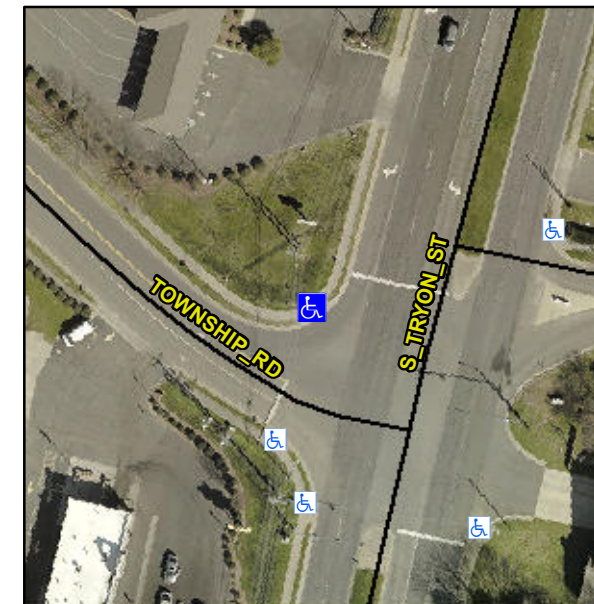
**Not Found, R304.5.1, R304.5.3**

Compliance	Description	Data	Compliance	Description	Data
N/A	Ramp Length (in)	30.0	Yes	Ramp Slope (%)	6.8
No	Ramp Width (in)	44.0	No	Ramp XSlope (%)	5.8
N/A	Flare Type LT	N/A	N/A	Flare Type RT	N/A
N/A	Flare Slope LT (%)	N/A	N/A	Flare Slope RT (%)	N/A
N/A	Flare Traversable LT?	N/A	N/A	Flare Traversable RT?	N/A
N/A	Landing Length (in)	N/A	N/A	DWS Provided?	N/A
N/A	Landing Width (in)	N/A	N/A	DWS Contrast?	N/A
N/A	Landing Slope (%)	N/A	N/A	DWS Length (in)	N/A
N/A	Landing X Slope (%)	N/A	N/A	DWS Full Width?	N/A
N/A	Landing Curb? (Y/N)	N/A	N/A	DWS Offset (in)	N/A
N/A	Shared Landing?	N/A			
N/A	Gutter Ponding?	N/A	N/A	Gutter Slope (%)	N/A
N/A	Gutter Lip Ht (in)	N/A	N/A	Gutter X Slope (%)	N/A
N/A	Painted X Walk1?	No	N/A	Painted X Walk2?	No
	X Walk 1 Direction	To SE		X Walk 2 Direction	To NE
N/A	X Walk 1 Width (in)	N/A	N/A	X Walk 2 Width (in)	N/A
	X Walk 1 Slope (%)	0.5		X Walk 2 Slope (%)	1.4
	X Walk 1 X Slope (%)	2.5		X Walk 2 X Slope (%)	0.4

N/A	Ramp inside XWalk1?	N/A	N/A	Ramp inside XWalk2?	N/A
	Road Slope (%)	1.1	N/A	Clear Space?	N/A
	Road X Slope (%)	2.2	N/A	Clear Space to XWalk (in)	N/A
N/A	Any Obstructions?	N/A	N/A	Storm Grate/Utility Hazard?	N/A
	Obstruction Type			Storm Grate/Utility Type	
		N/A			N/A
			Yes	Surface Condition? (G/P)	Good

**Remove & Replace Curb Ramp With Two New Directional Ramps or Equivalent.**
