Access Compliance Report

Public Rights-of-Way

(Curb Ramps)

Intersection ID: N/A	Main Street: TAMARACK DR	Cross Street: SINGLELEAF LN	Location: SE
ADA ID: 356A571E6F85	Ramp Type: Perp	Initial Pass/Fail: Pass	Overall Compliance: No
		Severity Score: 0

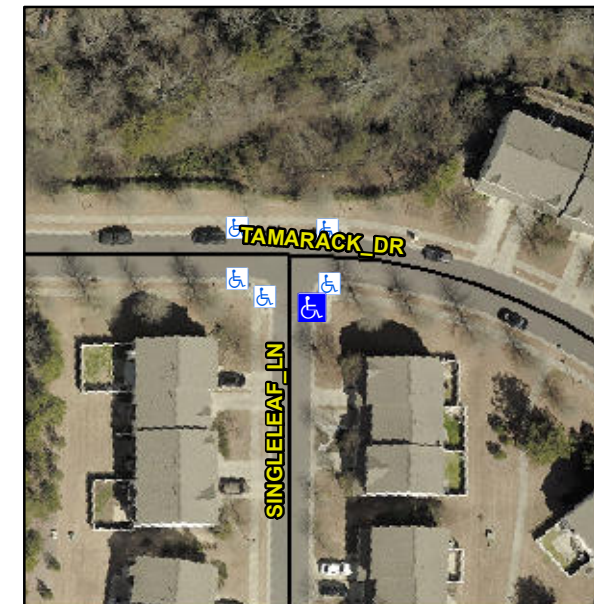
Not Found, R304.2.1, R305.2

Compliance	Description	Data	Compliance	Description	Data
N/A	Ramp Length (in)	48.0	Yes	Ramp Slope (%)	6.2
Yes	Ramp Width (in)	48.0	Yes	Ramp XSlope (%)	0.9
N/A	Flare Type LT	Sloped	N/A	Flare Type RT	N/A
N/A	Flare Slope LT (%)	5.3	N/A	Flare Slope RT (%)	7.5
N/A	Flare Traversable LT?	No	N/A	Flare Traversable RT?	No
No	Landing Length (in)	47.0	Yes	DWS Provided?	Yes
Yes	Landing Width (in)	48.0	Yes	DWS Contrast?	Yes
Yes	Landing Slope (%)	1.6	Yes	DWS Length (in)	24.0
Yes	Landing X Slope (%)	0.1	Yes	DWS Full Width?	Yes
N/A	Landing Curb? (Y/N)	No	No	DWS Offset (in)	6.5
N/A	Shared Landing?	No			
Yes	Gutter Ponding?	No	Yes	Gutter Slope (%)	0.4
Yes	Gutter Lip Ht (in)	0.0	Yes	Gutter X Slope (%)	0.4
N/A	Painted X Walk1?	No	N/A	Painted X Walk2?	N/A
	X Walk 1 Direction	To W		X Walk 2 Direction	N/A
N/A	X Walk 1 Width (in)	N/A	N/A	X Walk 2 Width (in)	N/A
	X Walk 1 Slope (%)	0.8		X Walk 2 Slope (%)	N/A
	X Walk 1 X Slope (%)	0.6		X Walk 2 X Slope (%)	N/A

N/A	Ramp inside XWalk1?	No	N/A	Ramp inside XWalk2?	N/A
	Road Slope (%)	N/A	N/A	Clear Space?	Yes
	Road X Slope (%)	N/A	N/A	Clear Space to XWalk (in)	N/A
Yes	Any Obstructions?	No	Yes	Storm Grate/Utility Hazard?	No
	Obstruction Type			Storm Grate/Utility Type	
		N/A			N/A
			Yes	Surface Condition? (G/P)	Good

Remove & Replace Entire Ramp.
