Access Compliance Report

Public Rights-of-Way

(Curb Ramps)

Intersection ID: 10032297	Main Street: MOUNTAIN_COVE_DR	Cross Street: N/A	Location: SW
ADA ID: 3572C623B9FD	Ramp Type: Perp	Initial Pass/Fail: Fail	Overall Compliance: No
			Severity Score: 37.5

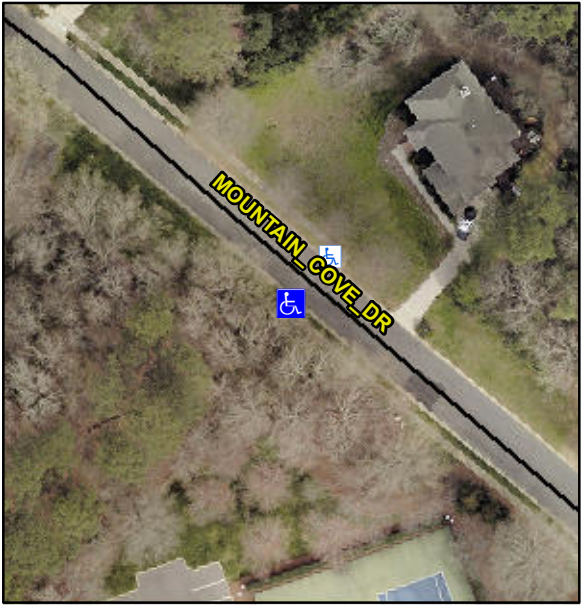
Possible Solutions:		Compliance	Description	Data
	Remove & Replace Entire Ramp.		No	Ramp Length (in)	91.0
			Yes	Ramp Width (in)	48.0
			N/A	Flare Type LT	N/A
			N/A	Flare Slope LT (%)	N/A
			N/A	Flare Traversable LT?	N/A
			N/A	Landing Length (in)	N/A
			N/A	Landing Width (in)	N/A
			N/A	Landing Slope (%)	N/A
			N/A	Landing X Slope (%)	N/A
<p>Surveyor Notes:</p> <p>N/A</p> <p>PROW/ADA:</p> <p>R304.2.2, R304.5.3</p>			N/A	Flare Type RT	N/A
			N/A	Flare Slope RT (%)	N/A
			N/A	Flare Traversable RT?	N/A
			N/A	DWS Provided?	N/A
			N/A	DWS Contrast?	N/A
			N/A	DWS Length (in)	N/A
			N/A	DWS Full Width?	N/A
			N/A	DWS Offset (in)	N/A
			N/A	Shared Landing?	N/A
			N/A	Gutter Ponding?	N/A
			N/A	Gutter Lip Ht (in)	N/A
			N/A	Painted X Walk1?	No
				X Walk 1 Direction	To NE
			N/A	X Walk 1 Width (in)	N/A
				X Walk 1 Slope (%)	2.2
				X Walk 1 X Slope (%)	9.6

N/A	Ramp inside XWalk1?	N/A
			N/A	Ramp inside XWalk2?	N/A
			N/A	Road Slope (%)	N/A
			N/A	Road X Slope (%)	N/A
			N/A	Any Obstructions?	N/A
				Obstruction Type	
			N/A	Clear Space?	N/A
			N/A	Clear Space to XWalk (in)	N/A
			N/A	Storm Grate/Utility Hazard?	N/A
				Storm Grate/Utility Type	
			N/A		N/A
			Yes	Surface Condition? (G/P)	Good
