Access Compliance Report

Public Rights-of-Way

(Curb Ramps)

Intersection ID: 24503	Main Street: BRUFF_CT	Cross Street: SAINTFIELD_PL	Location: SW
ADA ID: 357F92EEE61B	Ramp Type: Perp	Initial Pass/Fail: Fail	Overall Compliance: No
		Severity Score: 17.5

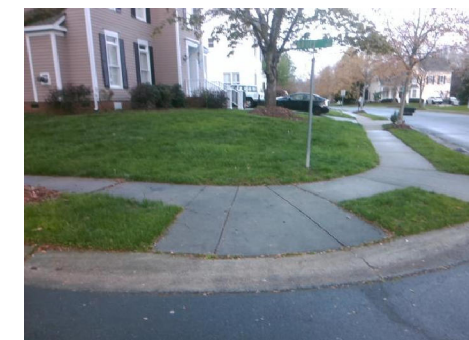
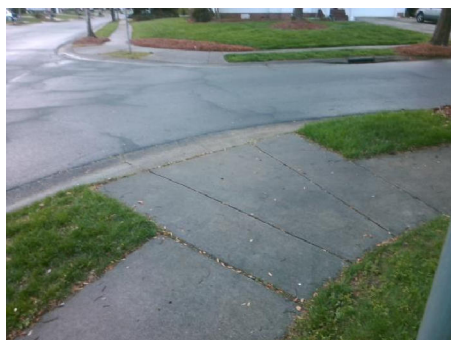
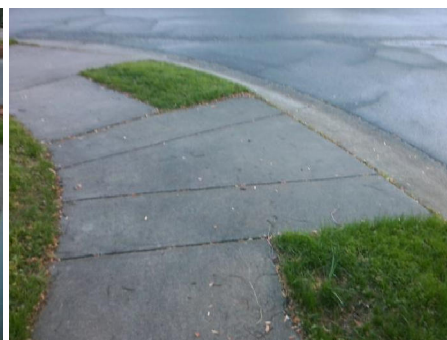
Compliance	Description	Data	Compliance	Description	Data
N/A	Ramp Length (in)	45.0	Yes	Ramp Slope (%)	6.3
No	Ramp Width (in)	35.0	Yes	Ramp XSlope (%)	1.3
N/A	Flare Type LT	N/A	N/A	Flare Type RT	N/A
N/A	Flare Slope LT (%)	N/A	N/A	Flare Slope RT (%)	N/A
N/A	Flare Traversable LT?	N/A	N/A	Flare Traversable RT?	N/A
N/A	Landing Length (in)	N/A	N/A	DWS Provided?	N/A
N/A	Landing Width (in)	N/A	N/A	DWS Contrast?	N/A
N/A	Landing Slope (%)	N/A	N/A	DWS Length (in)	N/A
N/A	Landing X Slope (%)	N/A	N/A	DWS Full Width?	N/A
N/A	Landing Curb? (Y/N)	N/A	N/A	DWS Offset (in)	N/A
N/A	Shared Landing?	N/A			
N/A	Gutter Ponding?	N/A	N/A	Gutter Slope (%)	N/A
N/A	Gutter Lip Ht (in)	N/A	N/A	Gutter X Slope (%)	N/A
N/A	Painted X Walk1?	No	N/A	Painted X Walk2?	N/A
	X Walk 1 Direction	To E		X Walk 2 Direction	N/A
N/A	X Walk 1 Width (in)	N/A	N/A	X Walk 2 Width (in)	N/A
	X Walk 1 Slope (%)	1.8		X Walk 2 Slope (%)	N/A
	X Walk 1 X Slope (%)	0.7		X Walk 2 X Slope (%)	N/A

N/A	Ramp inside XWalk1?	N/A	N/A	Ramp inside XWalk2?	N/A
	Road Slope (%)	N/A	N/A	Clear Space?	N/A
	Road X Slope (%)	N/A	N/A	Clear Space to XWalk (in)	N/A
N/A	Any Obstructions?	N/A	N/A	Storm Grate/Utility Hazard?	N/A
	Obstruction Type			Storm Grate/Utility Type	
		N/A			N/A
			Yes	Surface Condition? (G/P)	Good

Remove & Replace Entire Ramp.
