## **Access Compliance Report Public Rights-of-Way** (Curb Ramps)

Intersection ID: 14852 Main Street: HARRISBURG RD **Cross Street: SHACKLEFORD TR** Location: SW ADA ID: 358004A28F5A Ramp Type: PerpDiag Initial Pass/Fail: Fail **Overall Compliance: No Severity Score:** 12.5

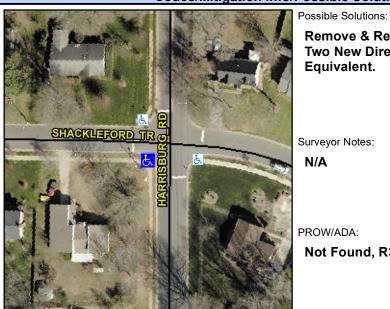
Compliance Description Date		Data	Compliance Description		Data
N/A	Ramp Length (in)	47.0	No	Ramp Slope (%)	10.8
Yes	Ramp Width (in)	96.0	Yes	Ramp XSlope (%)	0.6
N/A	Flare Type LT	N/A	N/A	Flare Type RT	N/A
N/A	Flare Slope LT (%)	N/A	N/A	Flare Slope RT (%)	N/A
N/A	Flare Traversable LT?	N/A	N/A	Flare Traversable RT?	N/A
N/A	Landing Length (in)	N/A	N/A	DWS Provided?	N/A
N/A	Landing Width (in)	N/A	N/A	DWS Contrast?	N/A
N/A	Landing Slope (%)	N/A	N/A	DWS Length (in)	N/A
N/A	Landing X Slope (%)	N/A	N/A	DWS Full Width?	N/A
N/A	Landing Curb? (Y/N)	N/A	N/A	DWS Offset (in)	N/A
N/A	Shared Landing?	N/A			
N/A	Gutter Ponding?	N/A	N/A	Gutter Slope (%)	N/A
N/A	Gutter Lip Ht (in)	N/A	N/A	Gutter X Slope (%)	N/A
N/A	Painted X Walk1?	No	N/A	Painted X Walk2?	No
	X Walk 1 Direction	To SE		X Walk 2 Direction	To NE
N/A	X Walk 1 Width (in)	N/A	N/A	X Walk 2 Width (in)	N/A
	X Walk 1 Slope (%)	1.3		X Walk 2 Slope (%)	0.4
	X Walk 1 X Slope (%)	0.7		X Walk 2 X Slope (%)	0.5

N/A	Ramp inside XWalk1?	N/A	N/A	Ramp inside XWalk2?	N/A
	Road Slope (%)	0.4	N/A	Clear Space?	N/A
	Road X Slope (%)	0.5	N/A	Clear Space to XWalk (in)	N/A
N/A	Any Obstructions?	N/A	N/A	Storm Grate/Utility Hazard?	N/A
	Obstruction Type			Storm Grate/Utility Type	
		N/A			N/A

Remove & Replace Curb Ramp With Two New Directional Ramps or Equivalent.
