Access Compliance Report

Public Rights-of-Way

(Curb Ramps)

Intersection ID: 18216	Main Street: FOREST_DR	Cross Street: S_WENDOVER_RD	Location: W
ADA ID: 3596CBAF8090	Ramp Type: BlendTrans2	Initial Pass/Fail: Pass	Overall Compliance: No
		Severity Score: 0

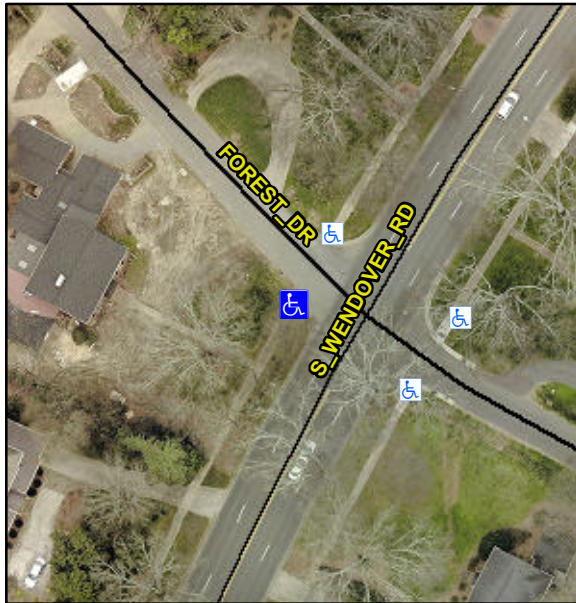
Field Measurements/Component Compliance

ASP LIP 0.5

Not Found, R305.2

Compliance	Description	Data	Compliance	Description	Data
N/A	Ramp Length (in)	63.0	Yes	BlendTrans Slope (%)	0.2
Yes	Ramp Width (in)	48.5	Yes	BlendTrans XSlope (%)	0.8
N/A	Flare Type LT	Sloped	N/A	Flare Type RT	Sloped
N/A	Flare Slope LT (%)	N/A	N/A	Flare Slope RT (%)	N/A
N/A	Flare Traversable LT?	No	N/A	Flare Traversable RT?	No
N/A	Landing Length (in)	N/A	Yes	DWS Provided?	Yes
N/A	Landing Width (in)	N/A	Yes	DWS Contrast?	Yes
N/A	Landing Slope (%)	N/A	Yes	DWS Length (in)	24.5
N/A	Landing X Slope (%)	N/A	Yes	DWS Full Width?	Yes
N/A	Landing Curb? (Y/N)	No	No	DWS Offset (in)	3.5
N/A	Shared Landing?	No			
Yes	Gutter Ponding?	No	Yes	Gutter Slope (%)	3.7
Yes	Gutter Lip Ht (in)	0.0	Yes	Gutter X Slope (%)	0.4
N/A	Painted X Walk1?	No	N/A	Painted X Walk2?	No
	X Walk 1 Direction	To SE		X Walk 2 Direction	To NE
	X Walk 1 Width (in)	N/A		X Walk 2 Width (in)	N/A
	X Walk 1 Slope (%)	1.8		X Walk 2 Slope (%)	4.3
	X Walk 1 X Slope (%)	3.5		X Walk 2 X Slope (%)	1.1

N/A	Ramp inside XWalk1?	N/A	N/A	Ramp inside XWalk2?	N/A
	Road Slope (%)	1.0		Clear Space?	Yes
	Road X Slope (%)	7.9	N/A	Clear Space to XWalk (in)	N/A
Yes	Any Obstructions?	No	Yes	Storm Grate/Utility Hazard?	No
	Obstruction Type			Storm Grate/Utility Type	
		N/A			N/A
			Yes	Surface Condition? (G/P)	Good
			No	Curb Slope (%)	29.2

Possible Solutions:

Remove & Replace Curb Ramp With Two New Directional Ramps or Equivalent.
