Access Compliance Report

Public Rights-of-Way

(Curb Ramps)

Intersection ID: 6882	Main Street: STATESVILLE_RD	Cross Street: CINDY_LN	Location: NW
ADA ID: 3597ED26D164	Ramp Type: Para	Initial Pass/Fail: Pass	Overall Compliance: No
		Severity Score: 0

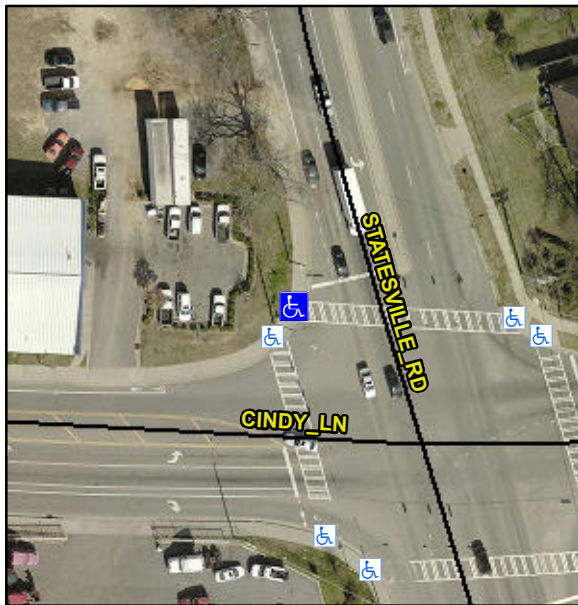
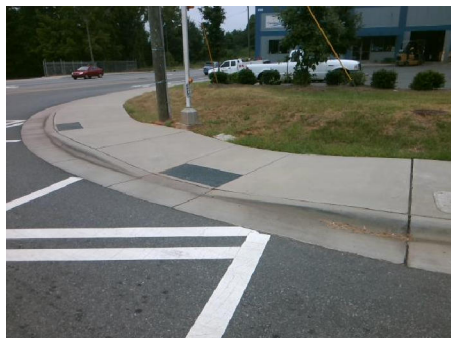
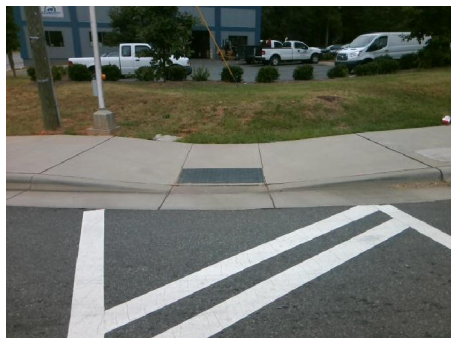
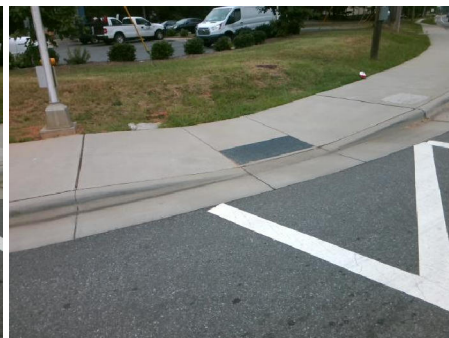
Compliance	Description	Data	Compliance	Description	Data
N/A	Ramp Length LT (in)	59.0	N/A	Ramp Length RT (in)	74.5
Yes	Ramp Width LT (in)	84.0	Yes	Ramp Width RT (in)	84.0
Yes	Ramp Slope LT (%)	5.3	Yes	Ramp Slope RT (%)	7.9
Yes	Ramp XSlope LT (%)	1.9	Yes	Ramp XSlope RT (%)	0.6
Yes	Landing Length (in)	84.0	Yes	DWS Provided?	Yes
Yes	Landing Width (in)	48.0	Yes	DWS Contrast?	Yes
Yes	Landing Slope (%)	0.7	Yes	DWS Length (in)	24.0
Yes	Landing X Slope (%)	0.8	Yes	DWS Full Width?	Yes
N/A	Landing Curb? (Y/N)	No	No	DWS Offset (in)	3.5
N/A	Shared Landing?	No			
Yes	Gutter Ponding?	No	Yes	Gutter Slope (%)	4.5
Yes	Gutter Lip Ht (in)	0.0	Yes	Gutter X Slope (%)	1.4
N/A	Painted X Walk1?	Yes	N/A	Painted X Walk2?	N/A
	X Walk 1 Direction	To E		X Walk 2 Direction	N/A
N/A	X Walk 1 Width (in)	110.5	N/A	X Walk 2 Width (in)	N/A
	X Walk 1 Slope (%)	2.8		X Walk 2 Slope (%)	N/A
	X Walk 1 X Slope (%)	0.5		X Walk 2 X Slope (%)	N/A
Yes	Ramp inside XWalk1?	Yes	N/A	Ramp inside XWalk2?	N/A

Road Slope (%)	N/A	N/A	Clear Space?	Yes
	Road X Slope (%)	N/A	N/A	Clear Space to XWalk (in)	N/A
Yes	Any Obstructions?	No	Yes	Storm Grate/Utility Hazard?	No
	Obstruction Type			Storm Grate/Utility Type	
		N/A			N/A
			Yes	Surface Condition? (G/P)	Good
			N/A	Curb Slope (%)	N/A

Possible Solutions:

Remove & Replace Detectable Warning System.
