Access Compliance Report

Public Rights-of-Way (Curb Ramps)

Intersection ID: 15217	Main Street: ALBEMARLE_RD	Cross Street: WINTERHAVEN_DR	Location: SW
ADA ID: 359BF5111939	Ramp Type: Perp	Initial Pass/Fail: Fail	Overall Compliance: No
Severity Score: 8.75			
Codes/Mitigation Info/Possible Solution		Field Measurements/Component Compliance

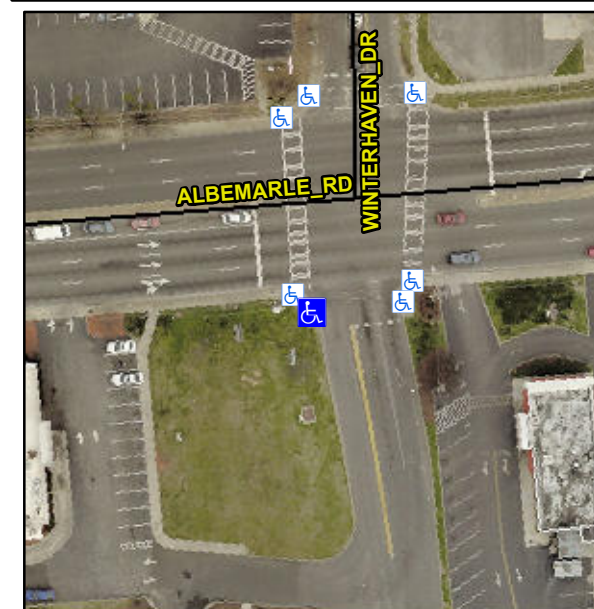
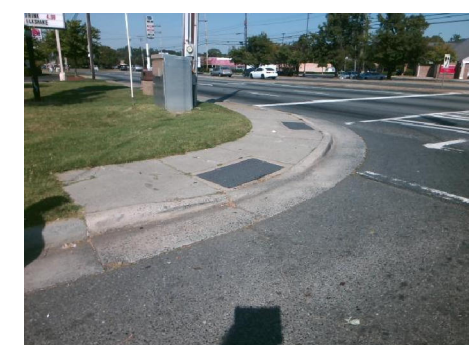
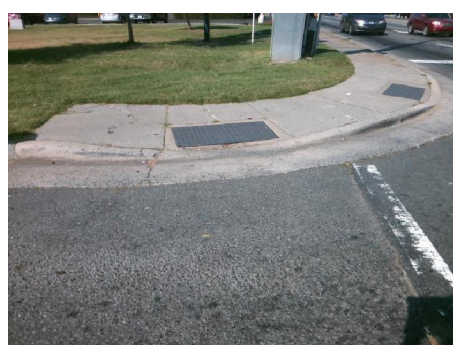
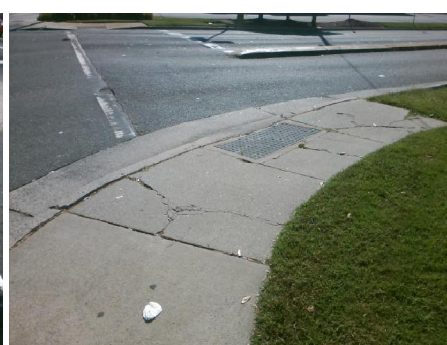
Compliance	Description	Data	Compliance	Description	Data
N/A	Ramp Length (in)	61.0	Yes	Ramp Slope (%)	7.5
No	Ramp Width (in)	41.0	Yes	Ramp XSlope (%)	1.1
N/A	Flare Type LT	N/A	N/A	Flare Type RT	N/A
N/A	Flare Slope LT (%)	N/A	N/A	Flare Slope RT (%)	N/A
N/A	Flare Traversable LT?	N/A	N/A	Flare Traversable RT?	N/A
N/A	Landing Length (in)	N/A	N/A	DWS Provided?	N/A
N/A	Landing Width (in)	N/A	N/A	DWS Contrast?	N/A
N/A	Landing Slope (%)	N/A	N/A	DWS Length (in)	N/A
N/A	Landing X Slope (%)	N/A	N/A	DWS Full Width?	N/A
N/A	Landing Curb? (Y/N)	N/A	N/A	DWS Offset (in)	N/A
N/A	Shared Landing?	N/A			
N/A	Gutter Ponding?	N/A	N/A	Gutter Slope (%)	N/A
N/A	Gutter Lip Ht (in)	N/A	N/A	Gutter X Slope (%)	N/A
N/A	Painted X Walk1?	Yes	N/A	Painted X Walk2?	N/A
	X Walk 1 Direction	To E		X Walk 2 Direction	N/A
N/A	X Walk 1 Width (in)	89.5	N/A	X Walk 2 Width (in)	N/A
	X Walk 1 Slope (%)	3.2		X Walk 2 Slope (%)	N/A
	X Walk 1 X Slope (%)	0.7		X Walk 2 X Slope (%)	N/A

N/A	Ramp inside XWalk1?	No	N/A	Ramp inside XWalk2?	N/A
	Road Slope (%)	N/A	N/A	Clear Space?	N/A
	Road X Slope (%)	N/A	N/A	Clear Space to XWalk (in)	N/A
N/A	Any Obstructions?	N/A	N/A	Storm Grate/Utility Hazard?	N/A
	Obstruction Type			Storm Grate/Utility Type	
		N/A			N/A
		Yes		Surface Condition? (G/P)	Good

**Remove & Replace Entire Ramp.
Restripe Crosswalk.**
