# Access Compliance Report

## Public Rights-of-Way

| Intersection ID: 6526 | Main Street: CENTURY_OAKS_LN | Cross Street: MINERAL_SPRINGS_RD | Location: NW |
| ADA ID: 35A4B48EA70E | Ramp Type: Perp | Initial Pass/Fail: Fail | Overall Compliance: No |

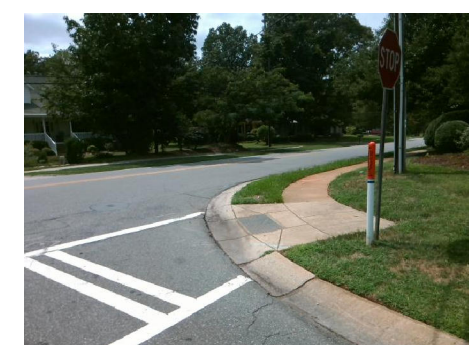
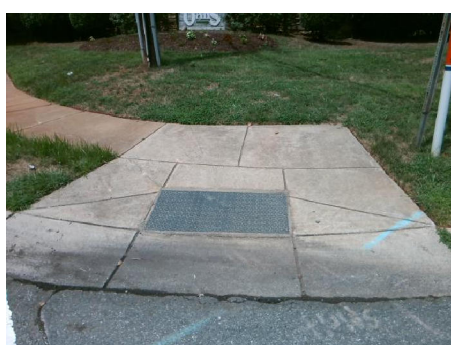
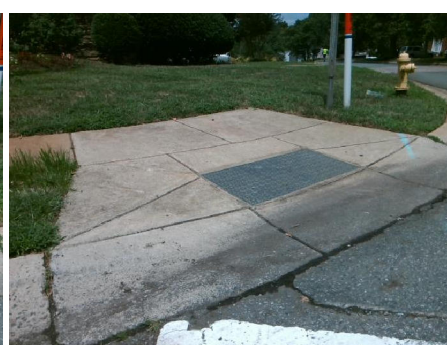
| Severity Score: 8.75 | | | |

**Not Found, R304.5.1**

| Compliance | Description | Data | Compliance | Description | Data |
|---|---|---|---|---|---|
| No | Ramp Width (in) | 45.5 | Yes | Ramp XSlope (%) | 1.5 |

**Remove & Replace Entire Ramp.**

Total Cost: \$ 1850.00
