# Access Compliance Report

## Public Rights-of-Way

### (Curb Ramps)

| Intersection ID: 22490 | Main Street: KENTDALE_CT | Cross Street: OXWYNN_LN | Location: NW |

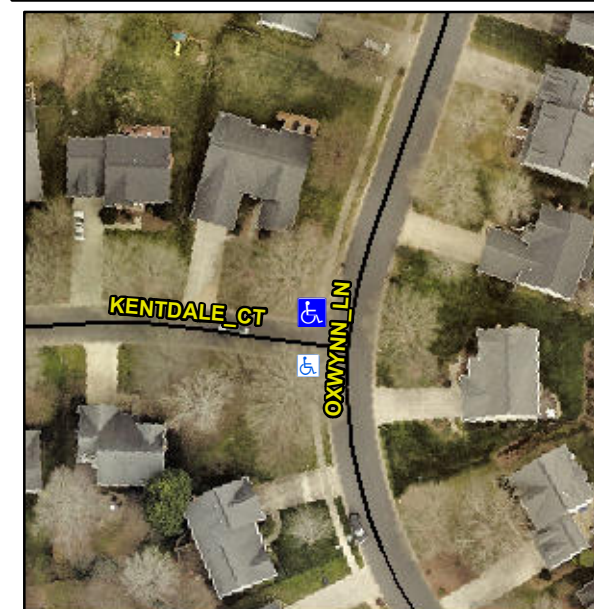
**R304.2.1, R304.2.2-Perp, R304.3.2-Para, R305.1.4, R305.2, R304.5.4**

| Compliance | Description | Data | Compliance | Description | Data |
|---|---|---|---|---|---|
| No | Landing Width (in) | 41.5 | Yes | DWS Contrast? | Yes |
| No | Landing Slope (%) | 2.6 | Yes | DWS Length (in) | 25.5 |
| Yes | Landing X Slope (%) | 0.2 | No | DWS Full Width? | No |
| N/A | Landing Curb? (Y/N) | No | No | DWS Offset (in) | 4.0 |
| Yes | Gutter Ponding? | No | No | Gutter Slope (%) | 7.3 |

**Remove & Replace Curb Ramp With Two New Directional Ramps or Equivalent. Remove & Replace Gutter.**

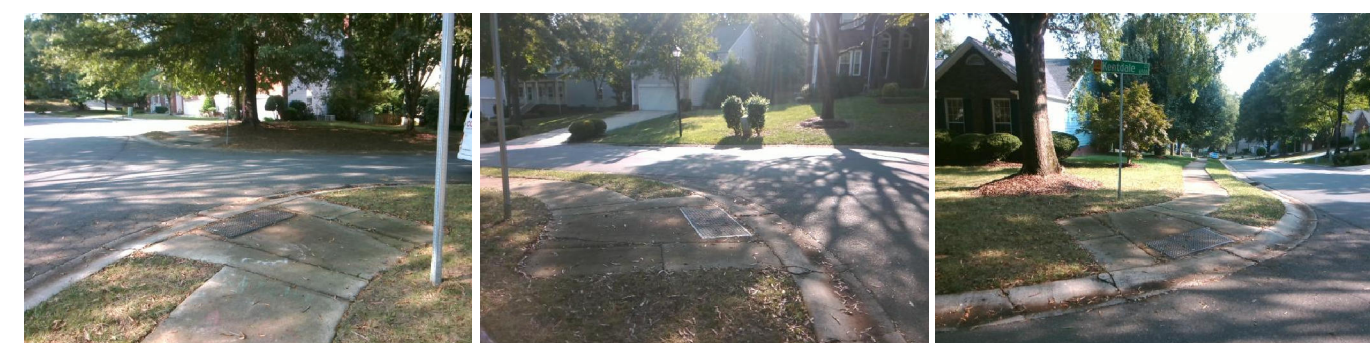
| ADA ID: 35AF721DE7F8 | Ramp Type: PerpDiag | Initial Pass/Fail: Pass | Overall Compliance: No |
| Severity Score: 7.5 | | | |
