# Access Compliance Report

## Public Rights-of-Way

### (Curb Ramps)

Intersection ID: 42469	Main Street: KINGSLEY_VIEW_DR	Cross Street: CASTLE_WATCH_AV	Location: NW
ADA ID: 35BA3558C626	Ramp Type: PerpDiag	Initial Pass/Fail: Fail	Overall Compliance: No
		Severity Score: 72.5

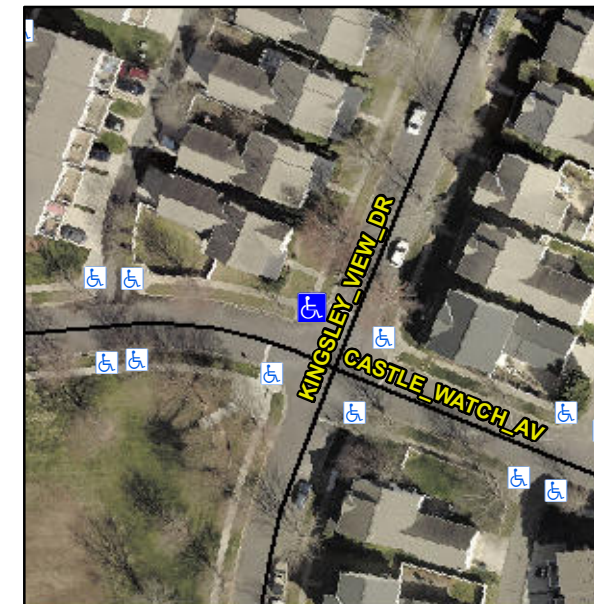
**R304.5.1, R304.2.2, R304.5.3**

Compliance	Description	Data	Compliance	Description	Data
N/A	Ramp Length (in)	120.0	No	Ramp Slope (%)	8.7
No	Ramp Width (in)	25.0	No	Ramp XSlope (%)	7.0
N/A	Flare Type LT	N/A	N/A	Flare Type RT	N/A
N/A	Flare Slope LT (%)	N/A	N/A	Flare Slope RT (%)	N/A
N/A	Flare Traversable LT?	N/A	N/A	Flare Traversable RT?	N/A
N/A	Landing Length (in)	N/A	N/A	DWS Provided?	N/A
N/A	Landing Width (in)	N/A	N/A	DWS Contrast?	N/A
N/A	Landing Slope (%)	N/A	N/A	DWS Length (in)	N/A
N/A	Landing X Slope (%)	N/A	N/A	DWS Full Width?	N/A
N/A	Landing Curb? (Y/N)	N/A	N/A	DWS Offset (in)	N/A
N/A	Shared Landing?	N/A			
N/A	Gutter Ponding?	N/A	N/A	Gutter Slope (%)	N/A
N/A	Gutter Lip Ht (in)	N/A	N/A	Gutter X Slope (%)	N/A
N/A	Painted X Walk1?	No	N/A	Painted X Walk2?	No
	X Walk 1 Direction	To SW		X Walk 2 Direction	To SE
N/A	X Walk 1 Width (in)	N/A	N/A	X Walk 2 Width (in)	N/A
	X Walk 1 Slope (%)	1.7		X Walk 2 Slope (%)	4.3
	X Walk 1 X Slope (%)	5.8		X Walk 2 X Slope (%)	2.4

N/A	Ramp inside XWalk1?	N/A	N/A	Ramp inside XWalk2?	N/A
	Road Slope (%)	6.1	N/A	Clear Space?	N/A
	Road X Slope (%)	2.3	N/A	Clear Space to XWalk (in)	N/A
N/A	Any Obstructions?	N/A	N/A	Storm Grate/Utility Hazard?	N/A
	Obstruction Type			Storm Grate/Utility Type	
		N/A			N/A
			Yes	Surface Condition? (G/P)	Good

**Remove & Replace Curb Ramp With Two New Directional Ramps or Equivalent.**
