# Access Compliance Report

## Public Rights-of-Way

### (Curb Ramps)

Intersection ID: 4232	Main Street: SALOME_CHURCH_RD	Cross Street: STONEY_VIEW_DR	Location: NW
ADA ID: 35BCB01E4223	Ramp Type: Perp	Initial Pass/Fail: Fail	Overall Compliance: No
		Severity Score: 50

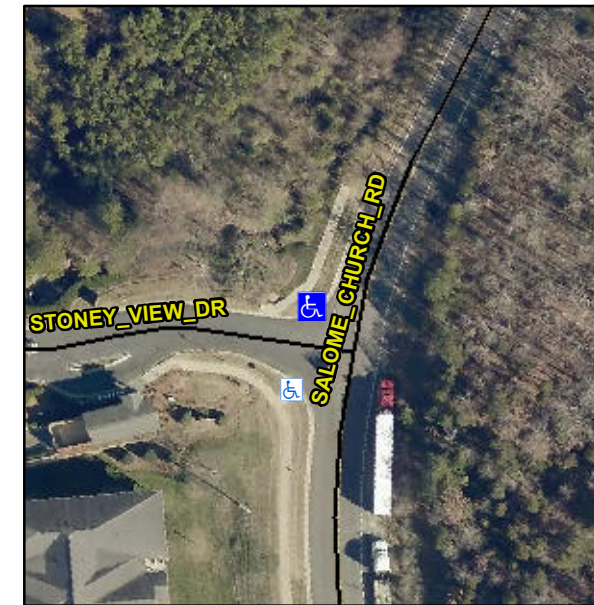
**Not Found, R304.2.2, R304.5.3**

Compliance	Description	Data	Compliance	Description	Data
N/A	Ramp Length (in)	96.0	No	Ramp Slope (%)	12.6
Yes	Ramp Width (in)	52.0	No	Ramp XSlope (%)	8.5
N/A	Flare Type LT	N/A	N/A	Flare Type RT	N/A
N/A	Flare Slope LT (%)	N/A	N/A	Flare Slope RT (%)	N/A
N/A	Flare Traversable LT?	N/A	N/A	Flare Traversable RT?	N/A
N/A	Landing Length (in)	N/A	N/A	DWS Provided?	N/A
N/A	Landing Width (in)	N/A	N/A	DWS Contrast?	N/A
N/A	Landing Slope (%)	N/A	N/A	DWS Length (in)	N/A
N/A	Landing X Slope (%)	N/A	N/A	DWS Full Width?	N/A
N/A	Landing Curb? (Y/N)	N/A	N/A	DWS Offset (in)	N/A
N/A	Shared Landing?	N/A			
N/A	Gutter Ponding?	N/A	N/A	Gutter Slope (%)	N/A
N/A	Gutter Lip Ht (in)	0.5	N/A	Gutter X Slope (%)	N/A
N/A	Painted X Walk1?	No	N/A	Painted X Walk2?	N/A
	X Walk 1 Direction	To S		X Walk 2 Direction	N/A
N/A	X Walk 1 Width (in)	N/A	N/A	X Walk 2 Width (in)	N/A
	X Walk 1 Slope (%)	3.4		X Walk 2 Slope (%)	N/A
	X Walk 1 X Slope (%)	1.6		X Walk 2 X Slope (%)	N/A

N/A	Ramp inside XWalk1?	N/A	N/A	Ramp inside XWalk2?	N/A
	Road Slope (%)	N/A	N/A	Clear Space?	N/A
	Road X Slope (%)	N/A	N/A	Clear Space to XWalk (in)	N/A
N/A	Any Obstructions?	N/A	N/A	Storm Grate/Utility Hazard?	N/A
	Obstruction Type			Storm Grate/Utility Type	
		N/A			N/A
			Yes	Surface Condition? (G/P)	Good

**Remove & Replace Entire Ramp.**
