Access Compliance Report

Public Rights-of-Way

(Curb Ramps)

Intersection ID: 27093	Main Street: MCKEE_RD	Cross Street: KNOX_AV	Location:	S
ADA ID: 35BD90FA3D95	Ramp Type: Perp	Initial Pass/Fail: Fail	Overall Compliance: No	Severity Score: 12.5
Codes/Mitigation Info/Possible Solution		Field Measurements/Component Compliance

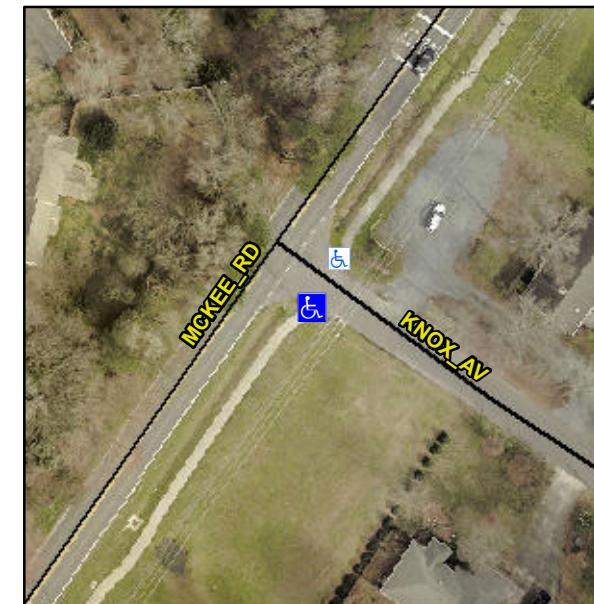
Compliance	Description	Data	Compliance	Description	Data
N/A	Ramp Length (in)	64.0	No	Ramp Slope (%)	8.4
Yes	Ramp Width (in)	72.0	Yes	Ramp XSlope (%)	1.1
N/A	Flare Type LT	N/A	N/A	Flare Type RT	N/A
N/A	Flare Slope LT (%)	N/A	N/A	Flare Slope RT (%)	N/A
N/A	Flare Traversable LT?	N/A	N/A	Flare Traversable RT?	N/A
N/A	Landing Length (in)	N/A	N/A	DWS Provided?	N/A
N/A	Landing Width (in)	N/A	N/A	DWS Contrast?	N/A
N/A	Landing Slope (%)	N/A	N/A	DWS Length (in)	N/A
N/A	Landing X Slope (%)	N/A	N/A	DWS Full Width?	N/A
N/A	Landing Curb? (Y/N)	N/A	N/A	DWS Offset (in)	N/A
N/A	Shared Landing?	N/A			
N/A	Gutter Ponding?	N/A	N/A	Gutter Slope (%)	N/A
N/A	Gutter Lip Ht (in)	N/A	N/A	Gutter X Slope (%)	N/A
N/A	Painted X Walk1?	No	N/A	Painted X Walk2?	N/A
	X Walk 1 Direction	To NE		X Walk 2 Direction	N/A
N/A	X Walk 1 Width (in)	N/A	N/A	X Walk 2 Width (in)	N/A
	X Walk 1 Slope (%)	2.6		X Walk 2 Slope (%)	N/A
	X Walk 1 X Slope (%)	1.7		X Walk 2 X Slope (%)	N/A

N/A	Ramp inside XWalk1?	N/A	N/A	Ramp inside XWalk2?	N/A
	Road Slope (%)	N/A	N/A	Clear Space?	N/A
	Road X Slope (%)	N/A	N/A	Clear Space to XWalk (in)	N/A
N/A	Any Obstructions?	N/A	N/A	Storm Grate/Utility Hazard?	N/A
	Obstruction Type			Storm Grate/Utility Type	
		N/A			N/A
			Yes	Surface Condition? (G/P)	Good

Possible Solutions:

Remove & Replace Entire Ramp.

R304.2.2
