# Access Compliance Report

## Public Rights-of-Way

### (Curb Ramps)

Intersection ID: 52839	Main Street: DOCIA_CROSSING_RD	Cross Street: ROBERT_HELMS_RD	Location: SW
ADA ID: 35C1AD5B7D41	Ramp Type: Perp	Initial Pass/Fail: Fail	Overall Compliance: No
Severity Score: 21.25			
Codes/Mitigation Info/Possible Solution		Field Measurements/Component Compliance

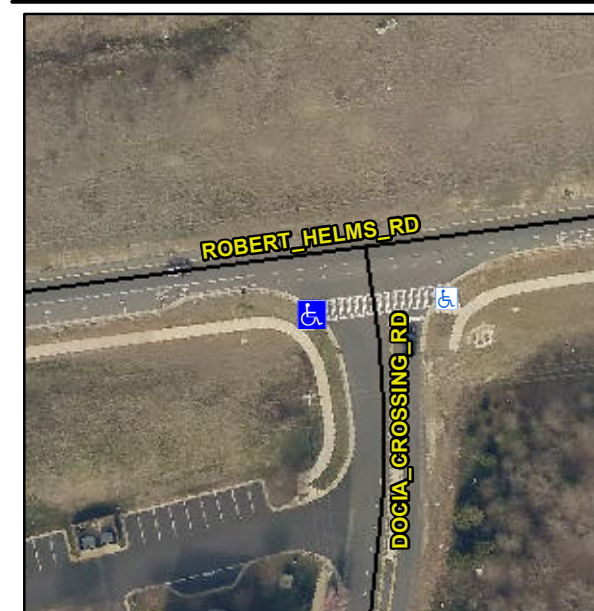
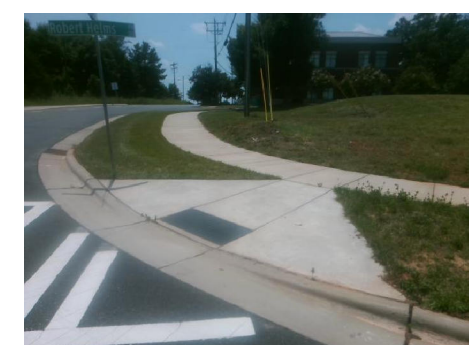
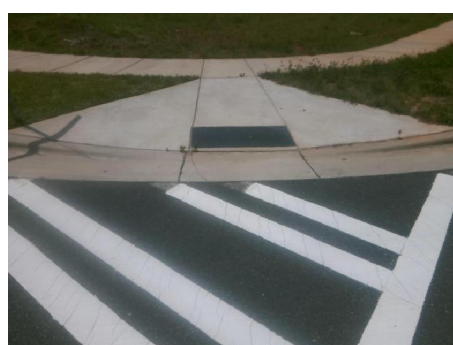
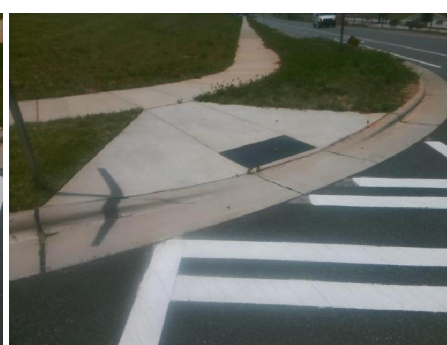
Compliance	Description	Data	Compliance	Description	Data
N/A	Ramp Length (in)	116.0	Yes	Ramp Slope (%)	7.5
No	Ramp Width (in)	40.0	No	Ramp XSlope (%)	6.5
N/A	Flare Type LT	N/A	N/A	Flare Type RT	N/A
N/A	Flare Slope LT (%)	N/A	N/A	Flare Slope RT (%)	N/A
N/A	Flare Traversable LT?	N/A	N/A	Flare Traversable RT?	N/A
N/A	Landing Length (in)	N/A	N/A	DWS Provided?	N/A
N/A	Landing Width (in)	N/A	N/A	DWS Contrast?	N/A
N/A	Landing Slope (%)	N/A	N/A	DWS Length (in)	N/A
N/A	Landing X Slope (%)	N/A	N/A	DWS Full Width?	N/A
N/A	Landing Curb? (Y/N)	N/A	N/A	DWS Offset (in)	N/A
N/A	Shared Landing?	N/A			
N/A	Gutter Ponding?	N/A	N/A	Gutter Slope (%)	N/A
N/A	Gutter Lip Ht (in)	N/A	N/A	Gutter X Slope (%)	N/A
N/A	Painted X Walk1?	Yes	N/A	Painted X Walk2?	N/A
	X Walk 1 Direction	To E		X Walk 2 Direction	N/A
N/A	X Walk 1 Width (in)	112.5	N/A	X Walk 2 Width (in)	N/A
	X Walk 1 Slope (%)	1.4		X Walk 2 Slope (%)	N/A
	X Walk 1 X Slope (%)	4.9		X Walk 2 X Slope (%)	N/A

N/A	Ramp inside XWalk1?	Yes	N/A	Ramp inside XWalk2?	N/A
	Road Slope (%)	N/A	N/A	Clear Space?	N/A
	Road X Slope (%)	N/A	N/A	Clear Space to XWalk (in)	N/A
N/A	Any Obstructions?	N/A	N/A	Storm Grate/Utility Hazard?	N/A
	Obstruction Type			Storm Grate/Utility Type	
		N/A			N/A
		Yes		Surface Condition? (G/P)	Good

**Remove & Replace Entire Ramp.**

**R304.5.1, R304.5.3**

Total Cost: \$ 1850.00
