Access Compliance Report

Public Rights-of-Way

(Curb Ramps)

Intersection ID: 8905	Main Street: BRADFORD_DR	Cross Street: KEY_ST	Location: SE
ADA ID: 35C78165F0A5	Ramp Type: Perp	Initial Pass/Fail: Fail	Overall Compliance: No
Severity Score: 12.5			
Codes/Mitigation Info/Possible Solution		Field Measurements/Component Compliance

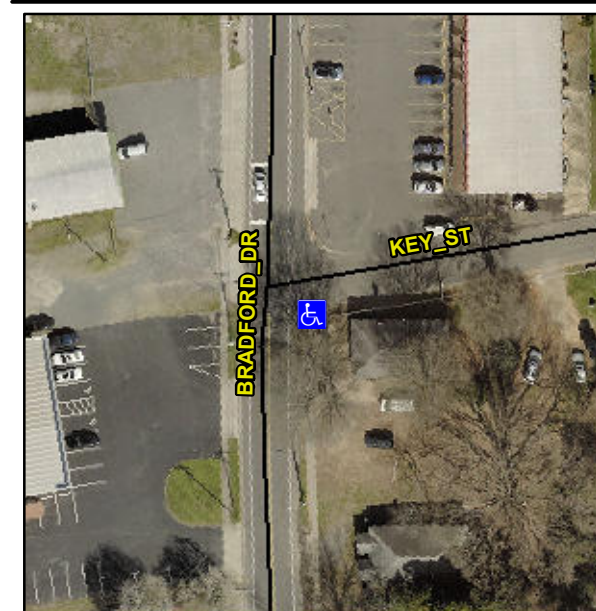
Not Found, R304.2.2

Compliance	Description	Data	Compliance	Description	Data
N/A	Ramp Length (in)	28.0	No	Ramp Slope (%)	9.2
Yes	Ramp Width (in)	48.0	Yes	Ramp XSlope (%)	1.8
N/A	Flare Type LT	N/A	N/A	Flare Type RT	N/A
N/A	Flare Slope LT (%)	N/A	N/A	Flare Slope RT (%)	N/A
N/A	Flare Traversable LT?	N/A	N/A	Flare Traversable RT?	N/A
N/A	Landing Length (in)	N/A	N/A	DWS Provided?	N/A
N/A	Landing Width (in)	N/A	N/A	DWS Contrast?	N/A
N/A	Landing Slope (%)	N/A	N/A	DWS Length (in)	N/A
N/A	Landing X Slope (%)	N/A	N/A	DWS Full Width?	N/A
N/A	Landing Curb? (Y/N)	N/A	N/A	DWS Offset (in)	N/A
N/A	Shared Landing?	N/A			
N/A	Gutter Ponding?	N/A	N/A	Gutter Slope (%)	N/A
N/A	Gutter Lip Ht (in)	N/A	N/A	Gutter X Slope (%)	N/A
N/A	Painted X Walk1?	No	N/A	Painted X Walk2?	N/A
	X Walk 1 Direction	To W		X Walk 2 Direction	N/A
N/A	X Walk 1 Width (in)	N/A	N/A	X Walk 2 Width (in)	N/A
	X Walk 1 Slope (%)	1.6		X Walk 2 Slope (%)	N/A
	X Walk 1 X Slope (%)	3.4		X Walk 2 X Slope (%)	N/A

N/A	Ramp inside XWalk1?	N/A	N/A	Ramp inside XWalk2?	N/A
	Road Slope (%)	3.4	N/A	Clear Space?	N/A
	Road X Slope (%)	1.6	N/A	Clear Space to XWalk (in)	N/A
N/A	Any Obstructions?	N/A	N/A	Storm Grate/Utility Hazard?	N/A
	Obstruction Type			Storm Grate/Utility Type	
		N/A			N/A
		Yes		Surface Condition? (G/P)	Good

Possible Solutions:

Remove & Replace Entire Ramp.
