Intersection ID: 8549	Main Street: LASALLE_ST	Cross Street: NEWCASTLE_ST	Location:	NW
ADA ID: 35CA9EDA4A69	Ramp Type: ParaDiag	Initial Pass/Fail: Fail	Overall Compliance: No	Severity Score: 12.5

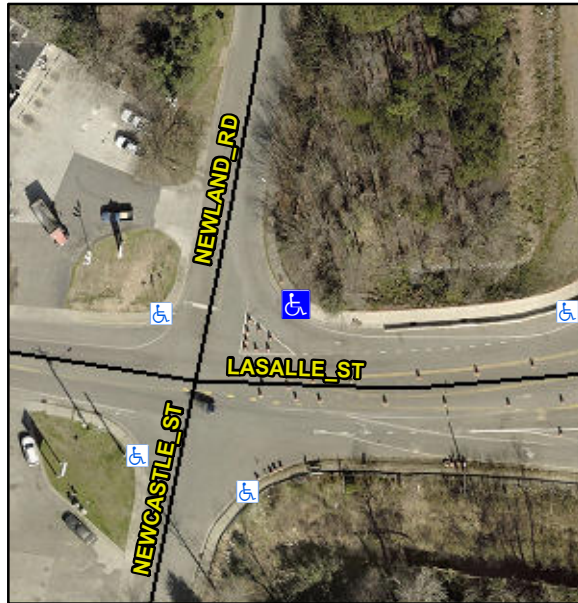
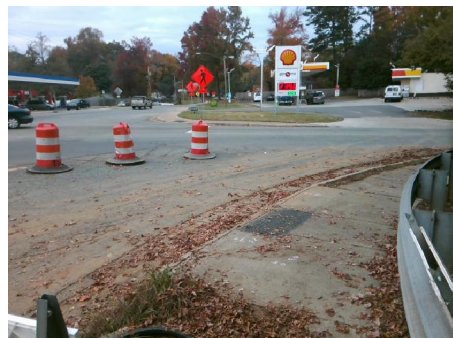
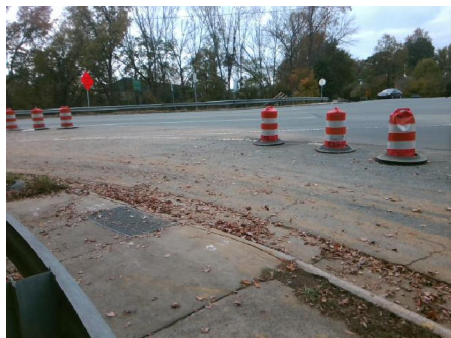
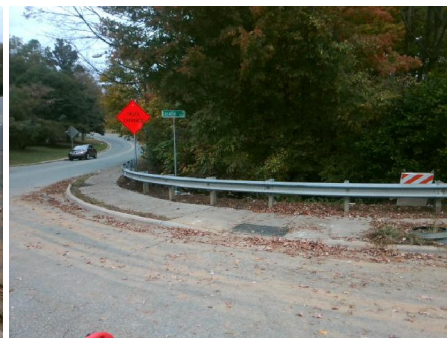
LT RP < 5%

Compliance	Description	Data	Compliance	Description	Data
N/A	Ramp Length LT (in)	60.0	N/A	Ramp Length RT (in)	63.0
Yes	Ramp Width LT (in)	70.0	Yes	Ramp Width RT (in)	72.0
Yes	Ramp Slope LT (%)	0.8	No	Ramp Slope RT (%)	9.0
Yes	Ramp XSlope LT (%)	0.8	Yes	Ramp XSlope RT (%)	0.5
N/A	Landing Length (in)	N/A	N/A	DWS Provided?	N/A
N/A	Landing Width (in)	N/A	N/A	DWS Contrast?	N/A
N/A	Landing Slope (%)	N/A	N/A	DWS Length (in)	N/A
N/A	Landing X Slope (%)	N/A	N/A	DWS Full Width?	N/A
N/A	Landing Curb? (Y/N)	N/A	N/A	DWS Offset (in)	N/A
N/A	Shared Landing?	N/A			
N/A	Gutter Ponding?	N/A	N/A	Gutter Slope (%)	N/A
N/A	Gutter Lip Ht (in)	N/A	N/A	Gutter X Slope (%)	N/A
N/A	Painted X Walk1?	No	N/A	Painted X Walk2?	No
	X Walk 1 Direction	To E		X Walk 2 Direction	To S
N/A	X Walk 1 Width (in)	N/A	N/A	X Walk 2 Width (in)	N/A
	X Walk 1 Slope (%)	6.2		X Walk 2 Slope (%)	7.7
	X Walk 1 X Slope (%)	1.3		X Walk 2 X Slope (%)	2.3
N/A	Ramp inside XWalk1?	N/A	N/A	Ramp inside XWalk2?	N/A

Road Slope (%)	2.1	N/A	Clear Space?	N/A
	Road X Slope (%)	4.0	N/A	Clear Space to XWalk (in)	N/A
N/A	Any Obstructions?	N/A	N/A	Storm Grate/Utility Hazard?	N/A
	Obstruction Type			Storm Grate/Utility Type	
		N/A			N/A
			Yes	Surface Condition? (G/P)	Good
			N/A	Curb Slope (%)	15.7

Remove & Replace Curb Ramp With Two New Directional Ramps or Equivalent.
