Access Compliance Report

Public Rights-of-Way

(Curb Ramps)

Intersection ID: 10038349	Main Street: SOUTH_BV	Cross Street: N/A	Location: E
ADA ID: 35D1409942C9	Ramp Type: Perp	Initial Pass/Fail: Fail	Overall Compliance: No
		Severity Score: 12.5

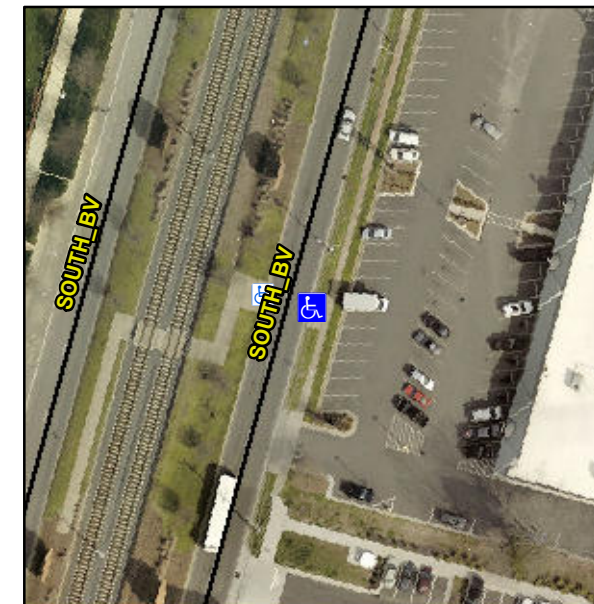
Not Found, R304.2.2

Compliance	Description	Data	Compliance	Description	Data
N/A	Ramp Length (in)	79.0	No	Ramp Slope (%)	8.6
Yes	Ramp Width (in)	84.0	Yes	Ramp XSlope (%)	2.0
N/A	Flare Type LT	N/A	N/A	Flare Type RT	N/A
N/A	Flare Slope LT (%)	N/A	N/A	Flare Slope RT (%)	N/A
N/A	Flare Traversable LT?	N/A	N/A	Flare Traversable RT?	N/A
N/A	Landing Length (in)	N/A	N/A	DWS Provided?	N/A
N/A	Landing Width (in)	N/A	N/A	DWS Contrast?	N/A
N/A	Landing Slope (%)	N/A	N/A	DWS Length (in)	N/A
N/A	Landing X Slope (%)	N/A	N/A	DWS Full Width?	N/A
N/A	Landing Curb? (Y/N)	N/A	N/A	DWS Offset (in)	N/A
N/A	Shared Landing?	N/A			
N/A	Gutter Ponding?	N/A	N/A	Gutter Slope (%)	N/A
N/A	Gutter Lip Ht (in)	N/A	N/A	Gutter X Slope (%)	N/A
N/A	Painted X Walk1?	No	N/A	Painted X Walk2?	N/A
	X Walk 1 Direction	To W		X Walk 2 Direction	N/A
N/A	X Walk 1 Width (in)	N/A	N/A	X Walk 2 Width (in)	N/A
	X Walk 1 Slope (%)	0.5		X Walk 2 Slope (%)	N/A
	X Walk 1 X Slope (%)	0.3		X Walk 2 X Slope (%)	N/A

N/A	Ramp inside XWalk1?	N/A	N/A	Ramp inside XWalk2?	N/A
	Road Slope (%)	N/A	N/A	Clear Space?	N/A
	Road X Slope (%)	N/A	N/A	Clear Space to XWalk (in)	N/A
N/A	Any Obstructions?	N/A	N/A	Storm Grate/Utility Hazard?	N/A
	Obstruction Type			Storm Grate/Utility Type	
		N/A			N/A
			Yes	Surface Condition? (G/P)	Good

Remove & Replace Entire Ramp.

Total Cost: \$ 1850.00
