## Access Compliance Report Public Rights-of-Way (Curb Ramps)

Intersection ID: N/A Main Street: YORKMONT\_RD Cross Street: OAK\_LAKE\_BV Location: SE

ADA ID: 35D40F508D7E Ramp Type: Para Initial Pass/Fail: Fail Overall Compliance: No Severity Score: 12.5

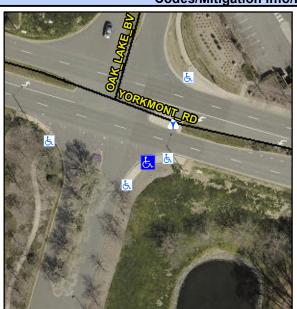
Compliance Description Data			Compliance Description Data		
N/A	Ramp Length LT (in)	61.0	N/A	Ramp Length RT (in)	63.0
Yes	Ramp Width LT (in)	84.0	Yes	Ramp Width RT (in)	84.0
No	Ramp Slope LT (%)	9.5	Yes	Ramp Slope RT (%)	5.1
Yes	Ramp XSlope LT (%)	0.1	Yes	Ramp XSlope RT (%)	0.4
N/A	Landing Length (in)	N/A	N/A	DWS Provided?	N/A
N/A	Landing Width (in)	N/A	N/A	DWS Contrast?	N/A
N/A	Landing Slope (%)	N/A	N/A	DWS Length (in)	N/A
N/A	Landing X Slope (%)	N/A	N/A	DWS Full Width?	N/A
N/A	Landing Curb? (Y/N)	N/A	N/A	DWS Offset (in)	N/A
N/A	Shared Landing?	N/A			
N/A	Gutter Ponding?	N/A	N/A	Gutter Slope (%)	N/A
N/A	Gutter Lip Ht (in)	N/A	N/A	Gutter X Slope (%)	N/A
N/A	Painted X Walk1?	No	N/A	Painted X Walk2?	N/A
	X Walk 1 Direction	To W		X Walk 2 Direction	N/A
N/A	X Walk 1 Width (in)	N/A	N/A	X Walk 2 Width (in)	N/A
	X Walk 1 Slope (%)	2.9		X Walk 2 Slope (%)	N/A
	X Walk 1 X Slope (%)	5.7		X Walk 2 X Slope (%)	N/A
N/A	Ramp inside XWalk1?	N/A	N/A	Ramp inside XWalk2?	N/A

Remove & Replace Entire Ramp.

R304.3.2
