# Access Compliance Report

## Public Rights-of-Way

### (Curb Ramps)

Intersection ID: N/A	Main Street: STONINGTON_LN	Cross Street: LAWYERS_RD	Location: NW
ADA ID: 35E248C1C6B2	Ramp Type: Directional2	Initial Pass/Fail: Fail	Overall Compliance: No
Codes/Mitigation Info/Possible Solution		Field Measurements/Component Compliance	
Severity Score: 25

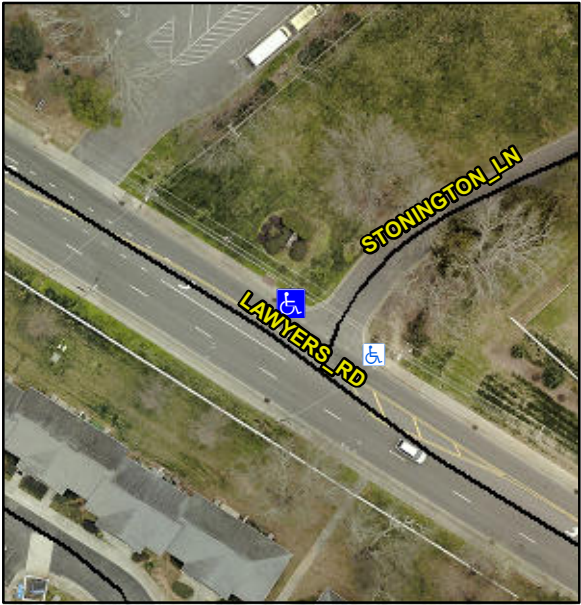
Possible Solutions:						
	Remove & Replace Entire Ramp.						
	Surveyor Notes:  N/A	Compliance	Description	Data	Compliance	Description	Data
		N/A	Ramp Length (in)	81.0	N/A	Grade Break?	N/A
		Yes	Ramp Width (in)	48.0	N/A	Grade Break Slope (%)	0.0
		Yes	Ramp Slope (%)	8.2	N/A	Grade Break XSlope (%)	0.0
		No	Ramp XSlope (%)	12.0			
		N/A	Flare Type LT	N/A	N/A	Flare Type RT	N/A
		N/A	Flare Slope LT (%)	N/A	N/A	Flare Slope RT (%)	0.0
		N/A	Flare Traversable LT?	N/A	N/A	Flare Traversable RT?	N/A
		N/A	Landing Length (in)	0.0	N/A	DWS Provided?	N/A
		N/A	Landing Width (in)	0.0	N/A	DWS Contrast?	N/A
	PROW/ADA:  R304.5.3	N/A	Landing Slope (%)	0.0	N/A	DWS Length (in)	N/A
		N/A	Landing X Slope (%)	0.0	N/A	DWS Full Width?	N/A
		N/A	Landing Curb? (Y/N)	N/A	N/A	DWS Offset LT (in)	N/A
		N/A	Shared Landing?	N/A	N/A	DWS Offset RT (in)	N/A
		N/A	Gutter Ponding?	0.0	N/A	Gutter Slope (%)	N/A
		N/A	Gutter Lip Ht (in)	1.5	N/A	Gutter X Slope (%)	N/A

N/A	Painted X Walk1?	No		Road Slope (%)	1.3
			X Walk 1 Direction	To SE		Road X Slope (%)	0.7
			X Walk 1 Width (in)	N/A		Clear Space?	N/A
			X Walk 1 Slope (%)	1.3	N/A	Clear Space to XWalk (in)	N/A
			X Walk 1 X Slope (%)	0.7	N/A	Storm Grate/Utility Hazard?	N/A
		N/A	Ramp inside XWalk1?	N/A		Storm Grate/Utility Type	
		N/A	Any Obstructions?	N/A			N/A
			Obstruction Type		Yes	Surface Condition? (G/P)	Good
					N/A	Curb Slope (%)	0.3
	Total Cost:	\$	1800.00
