Access Compliance Report

Public Rights-of-Way

(Curb Ramps)

Intersection ID: 45978	Main Street: NIKKI_COLE_DR	Cross Street: KAYLA_LN	Location: NW
ADA ID: 35E52E997801	Ramp Type: Perp	Initial Pass/Fail: Fail	Overall Compliance: No
Severity Score: 13.75			
Codes/Mitigation Info/Possible Solution		Field Measurements/Component Compliance

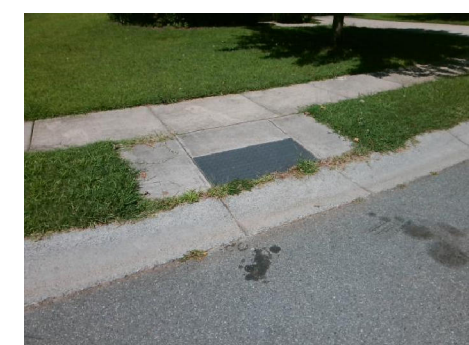
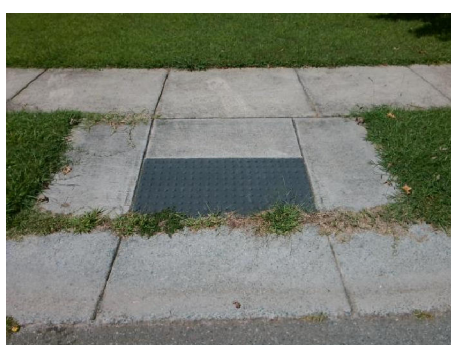
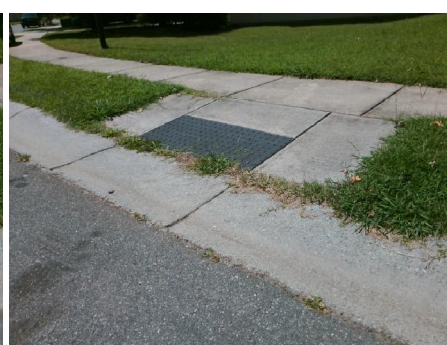
Not Found, R304.2.2, R304.5.3

Compliance	Description	Data	Compliance	Description	Data
N/A	Ramp Length (in)	48.0	No	Ramp Slope (%)	11.3
Yes	Ramp Width (in)	48.0	No	Ramp XSlope (%)	3.8
N/A	Flare Type LT	N/A	N/A	Flare Type RT	N/A
N/A	Flare Slope LT (%)	N/A	N/A	Flare Slope RT (%)	N/A
N/A	Flare Traversable LT?	N/A	N/A	Flare Traversable RT?	N/A
N/A	Landing Length (in)	N/A	N/A	DWS Provided?	N/A
N/A	Landing Width (in)	N/A	N/A	DWS Contrast?	N/A
N/A	Landing Slope (%)	N/A	N/A	DWS Length (in)	N/A
N/A	Landing X Slope (%)	N/A	N/A	DWS Full Width?	N/A
N/A	Landing Curb? (Y/N)	N/A	N/A	DWS Offset (in)	N/A
N/A	Shared Landing?	N/A			
N/A	Gutter Ponding?	N/A	N/A	Gutter Slope (%)	N/A
N/A	Gutter Lip Ht (in)	0.5	N/A	Gutter X Slope (%)	N/A
N/A	Painted X Walk1?	No	N/A	Painted X Walk2?	N/A
	X Walk 1 Direction	To SE		X Walk 2 Direction	N/A
N/A	X Walk 1 Width (in)	N/A	N/A	X Walk 2 Width (in)	N/A
	X Walk 1 Slope (%)	1.2		X Walk 2 Slope (%)	N/A
	X Walk 1 X Slope (%)	3.0		X Walk 2 X Slope (%)	N/A

N/A	Ramp inside XWalk1?	N/A	N/A	Ramp inside XWalk2?	N/A
	Road Slope (%)	N/A	N/A	Clear Space?	N/A
	Road X Slope (%)	N/A	N/A	Clear Space to XWalk (in)	N/A
N/A	Any Obstructions?	N/A	N/A	Storm Grate/Utility Hazard?	N/A
	Obstruction Type			Storm Grate/Utility Type	
		N/A			N/A
			Yes	Surface Condition? (G/P)	Good

Remove & Replace Entire Ramp.

Total Cost: \$ 1850.00
