Access Compliance Report

Public Rights-of-Way

(Curb Ramps)

Intersection ID: 9440	Main Street: BRADFORD_DR	Cross Street: EDGEWOOD_RD	Location:	N
ADA ID: 35F45E1ABEFE	Ramp Type: Perp	Initial Pass/Fail: Fail	Overall Compliance: No	Severity Score: 13.75

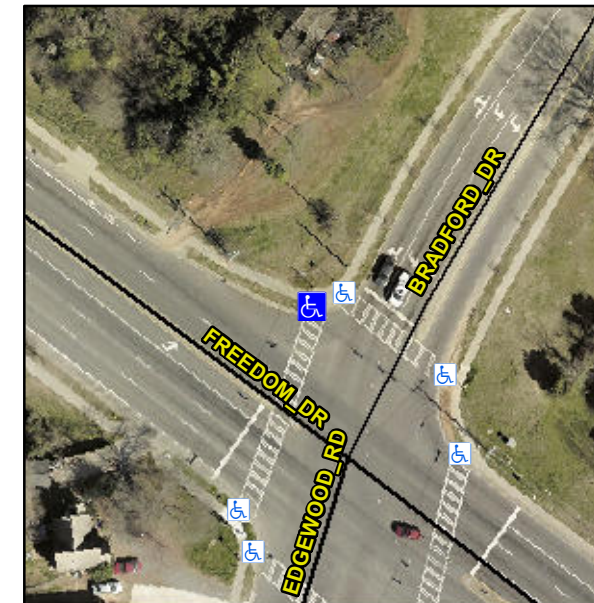
Not Found, R304.2.2

Compliance	Description	Data	Compliance	Description	Data
N/A	Ramp Length (in)	60.0	No	Ramp Slope (%)	8.9
Yes	Ramp Width (in)	48.0	Yes	Ramp XSlope (%)	2.9
N/A	Flare Type LT	N/A	N/A	Flare Type RT	N/A
N/A	Flare Slope LT (%)	N/A	N/A	Flare Slope RT (%)	N/A
N/A	Flare Traversable LT?	N/A	N/A	Flare Traversable RT?	N/A
N/A	Landing Length (in)	N/A	N/A	DWS Provided?	N/A
N/A	Landing Width (in)	N/A	N/A	DWS Contrast?	N/A
N/A	Landing Slope (%)	N/A	N/A	DWS Length (in)	N/A
N/A	Landing X Slope (%)	N/A	N/A	DWS Full Width?	N/A
N/A	Landing Curb? (Y/N)	N/A	N/A	DWS Offset (in)	N/A
N/A	Shared Landing?	N/A			
N/A	Gutter Ponding?	N/A	N/A	Gutter Slope (%)	N/A
N/A	Gutter Lip Ht (in)	N/A	N/A	Gutter X Slope (%)	N/A
N/A	Painted X Walk1?	Yes	N/A	Painted X Walk2?	N/A
	X Walk 1 Direction	To SW		X Walk 2 Direction	N/A
N/A	X Walk 1 Width (in)	116.0	N/A	X Walk 2 Width (in)	N/A
	X Walk 1 Slope (%)	0.7		X Walk 2 Slope (%)	N/A
	X Walk 1 X Slope (%)	3.9		X Walk 2 X Slope (%)	N/A

Remove & Replace Entire Ramp.

Total Cost: \$ 1850.00
