# Access Compliance Report

## Public Rights-of-Way (Curb Ramps)

Intersection ID: 48960	Main Street: FRANKLIN_SQUARE_RD	Cross Street: BONROI_AV	Location: W
ADA ID: 35FA3D64EFAB	Ramp Type: BlendTrans1	Initial Pass/Fail: Fail	Overall Compliance: No
		Severity Score: 10

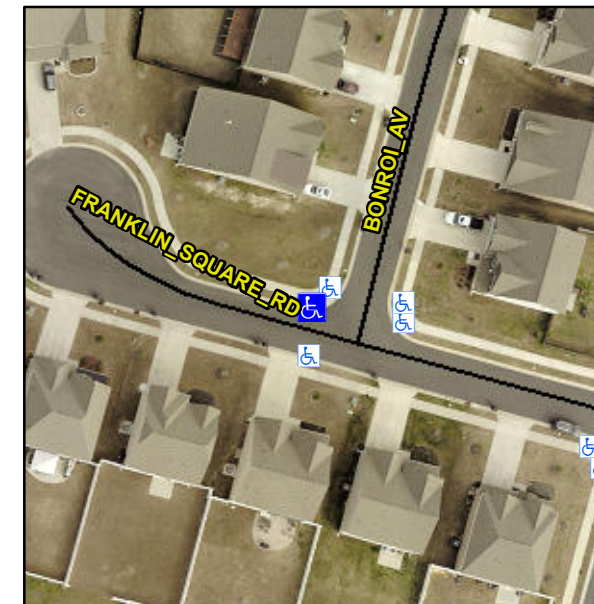
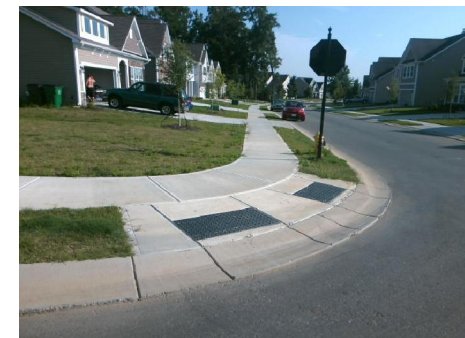
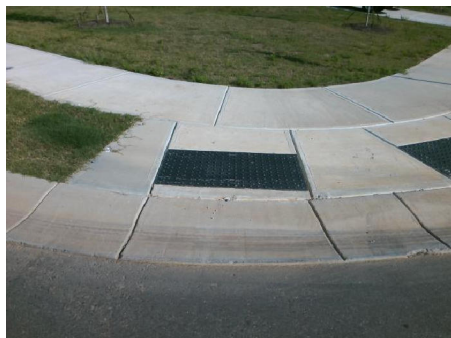
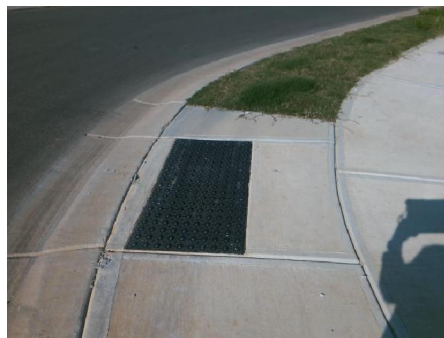
**Not Found, R304.5.1, R304.5.3**

Compliance	Description	Data	Compliance	Description	Data
N/A	Ramp Length (in)	54.5	Yes	BlendTrans Slope (%)	3.5
No	Ramp Width (in)	47.5	No	BlendTrans XSlope (%)	4.9
N/A	Flare Type LT	N/A	N/A	Flare Type RT	N/A
N/A	Flare Slope LT (%)	N/A	N/A	Flare Slope RT (%)	N/A
N/A	Flare Traversable LT?	N/A	N/A	Flare Traversable RT?	N/A
N/A	Landing Length (in)	N/A	N/A	DWS Provided?	N/A
N/A	Landing Width (in)	N/A	N/A	DWS Contrast?	N/A
N/A	Landing Slope (%)	N/A	N/A	DWS Length (in)	N/A
N/A	Landing X Slope (%)	N/A	N/A	DWS Full Width?	N/A
N/A	Landing Curb? (Y/N)	N/A	N/A	DWS Offset (in)	N/A
N/A	Shared Landing?	N/A			
N/A	Gutter Ponding?	N/A	N/A	Gutter Slope (%)	N/A
N/A	Gutter Lip Ht (in)	1.0	N/A	Gutter X Slope (%)	N/A
N/A	Painted X Walk1?	No	N/A	Painted X Walk2?	N/A
	X Walk 1 Direction	To S		X Walk 2 Direction	N/A
	X Walk 1 Width (in)	N/A		X Walk 2 Width (in)	N/A
	X Walk 1 Slope (%)	3.7		X Walk 2 Slope (%)	N/A
	X Walk 1 X Slope (%)	2.1		X Walk 2 X Slope (%)	N/A

N/A	Ramp inside XWalk1?	N/A	N/A	Ramp inside XWalk2?	N/A
	Road Slope (%)	2.1		Clear Space?	N/A
	Road X Slope (%)	3.7	N/A	Clear Space to XWalk (in)	N/A
N/A	Any Obstructions?	N/A	N/A	Storm Grate/Utility Hazard?	N/A
	Obstruction Type			Storm Grate/Utility Type	
		N/A			N/A
			Yes	Surface Condition? (G/P)	Good
			No	Curb Slope (%)	19.4

**Remove & Replace Curb Ramp With Two New Directional Ramps or Equivalent.**

Total Cost: \$ 3200.00
