Access Compliance Report

Public Rights-of-Way

(Curb Ramps)

Intersection ID: N/A	Main Street: MATTHEWS_FARM_LN	Cross Street: N/A	Location: NE
ADA ID: 360BAEBF0B5D	Ramp Type: Perp	Initial Pass/Fail: Pass	Overall Compliance: No
Severity Score: 0			
Codes/Mitigation Info/Possible Solution		Field Measurements/Component Compliance

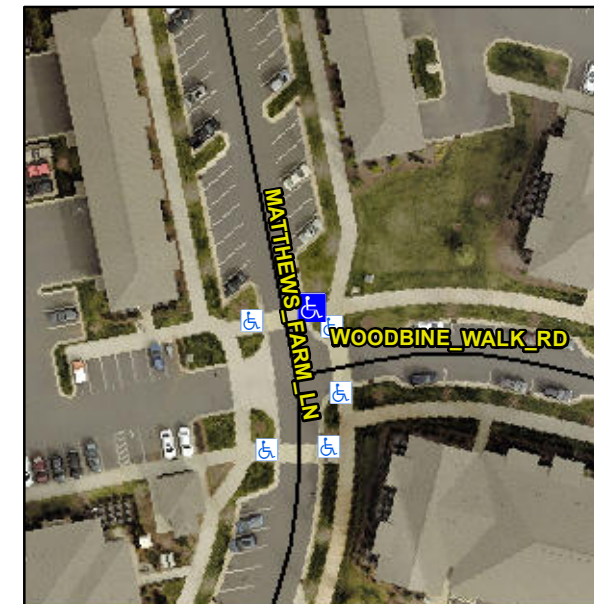
Not Found, R305.2

Compliance	Description	Data	Compliance	Description	Data
N/A	Ramp Length (in)	103.0	Yes	Ramp Slope (%)	6.7
Yes	Ramp Width (in)	88.0	Yes	Ramp XSlope (%)	0.6
Yes	Flare Type L	Curbed_NoWalkSurface	Yes	Flare Type RT	N/A
Yes	Flare Slope LT (%)	N/A	N/A	Flare Slope RT (%)	N/A
N/A	Flare Traversable LT?	No	N/A	Flare Traversable RT?	No
Yes	Landing Length (in)	100.0	Yes	DWS Provided?	Yes
Yes	Landing Width (in)	88.0	Yes	DWS Contrast?	Yes
Yes	Landing Slope (%)	1.7	Yes	DWS Length (in)	24.0
Yes	Landing X Slope (%)	1.8	Yes	DWS Full Width?	Yes
N/A	Landing Curb? (Y/N)	No	No	DWS Offset (in)	2.5
N/A	Shared Landing?	No			
Yes	Gutter Ponding?	No	Yes	Gutter Slope (%)	2.6
Yes	Gutter Lip Ht (in)	0.0	Yes	Gutter X Slope (%)	0.8
N/A	Painted X Walk1?	No	N/A	Painted X Walk2?	N/A
	X Walk 1 Direction	To W		X Walk 2 Direction	N/A
N/A	X Walk 1 Width (in)	N/A	N/A	X Walk 2 Width (in)	N/A
	X Walk 1 Slope (%)	1.9		X Walk 2 Slope (%)	N/A
	X Walk 1 X Slope (%)	1.1		X Walk 2 X Slope (%)	N/A

N/A	Ramp inside XWalk1?	N/A	N/A	Ramp inside XWalk2?	N/A
	Road Slope (%)	N/A	N/A	Clear Space?	Yes
	Road X Slope (%)	N/A	N/A	Clear Space to XWalk (in)	N/A
Yes	Any Obstructions?	No	Yes	Storm Grate/Utility Hazard?	No
	Obstruction Type			Storm Grate/Utility Type	
		N/A			N/A
			Yes	Surface Condition? (G/P)	Good

Possible Solutions:

Remove & Replace Entire Ramp.
