Access Compliance Report

Public Rights-of-Way

(Curb Ramps)

Intersection ID: 44167	Main Street: BRANDYBUCK_LN	Cross Street: COCHRANE_DR	Location: SW
ADA ID: 361C7D9E03F4	Ramp Type: BlendTrans1	Initial Pass/Fail: Fail	Overall Compliance: No
Codes/Mitigation Info/Possible Solution		Field Measurements/Component Compliance	
Severity Score: 17.5

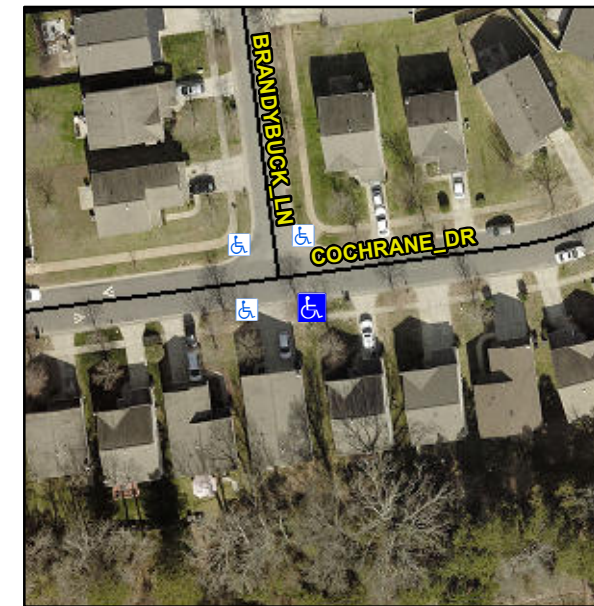
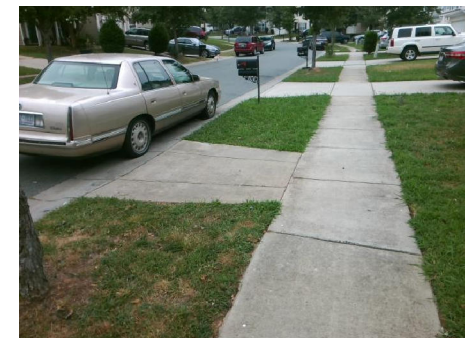
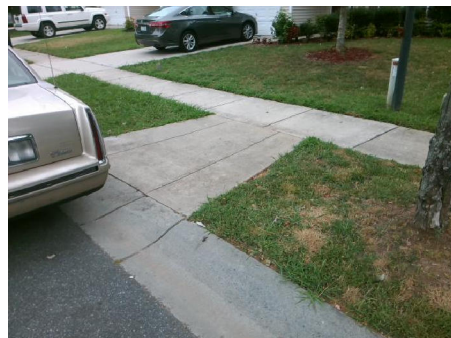
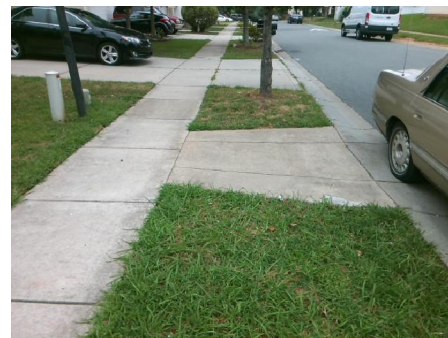
Not Found, R304.5.1

Compliance	Description	Data	Compliance	Description	Data
N/A	Ramp Length (in)	84.5	Yes	BlendTrans Slope (%)	4.8
No	Ramp Width (in)	34.5	Yes	BlendTrans XSlope (%)	1.5
N/A	Flare Type LT	N/A	N/A	Flare Type RT	N/A
N/A	Flare Slope LT (%)	N/A	N/A	Flare Slope RT (%)	N/A
N/A	Flare Traversable LT?	N/A	N/A	Flare Traversable RT?	N/A
N/A	Landing Length (in)	N/A	N/A	DWS Provided?	N/A
N/A	Landing Width (in)	N/A	N/A	DWS Contrast?	N/A
N/A	Landing Slope (%)	N/A	N/A	DWS Length (in)	N/A
N/A	Landing X Slope (%)	N/A	N/A	DWS Full Width?	N/A
N/A	Landing Curb? (Y/N)	N/A	N/A	DWS Offset (in)	N/A
N/A	Shared Landing?	N/A			
N/A	Gutter Ponding?	N/A	N/A	Gutter Slope (%)	N/A
N/A	Gutter Lip Ht (in)	N/A	N/A	Gutter X Slope (%)	N/A
N/A	Painted X Walk1?	No	N/A	Painted X Walk2?	N/A
	X Walk 1 Direction	To N		X Walk 2 Direction	N/A
	X Walk 1 Width (in)	N/A		X Walk 2 Width (in)	N/A
	X Walk 1 Slope (%)	4.0		X Walk 2 Slope (%)	N/A
	X Walk 1 X Slope (%)	1.1		X Walk 2 X Slope (%)	N/A

N/A	Ramp inside XWalk1?	N/A	N/A	Ramp inside XWalk2?	N/A
	Road Slope (%)	1.1		Clear Space?	N/A
	Road X Slope (%)	4.0	N/A	Clear Space to XWalk (in)	N/A
N/A	Any Obstructions?	N/A	N/A	Storm Grate/Utility Hazard?	N/A
	Obstruction Type			Storm Grate/Utility Type	
		N/A			N/A
			Yes	Surface Condition? (G/P)	Good
			No	Curb Slope (%)	13.5

Possible Solutions:

Remove & Replace Curb Ramp With Two New Directional Ramps or Equivalent.
