# Access Compliance Report

## Public Rights-of-Way

### (Curb Ramps)

| Intersection ID: 53157 | Main Street: DALLAS_BAY_RD | Cross Street: HAMILTON_BRIDGE_RD | Location: SW |

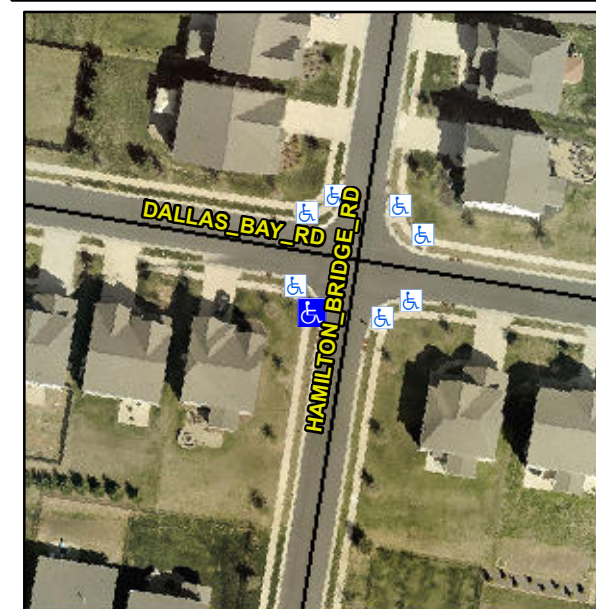
**Not Found, R304.5.1, R304.2.2, R304.5.3**

| Compliance | Description | Data | Compliance | Description | Data |
|---|---|---|---|---|---|
| N/A | Ramp Length (in) | 50.0 | No | Ramp Slope (%) | 9.4 |
| No | Ramp Width (in) | 47.5 | No | Ramp XSlope (%) | 2.1 |

**Remove & Replace Entire Ramp.**

Total Cost: \$ 1850.00
