Access Compliance Report

Public Rights-of-Way

(Curb Ramps)

Intersection ID: 48421	Main Street: EVANTON_LOCH_RD	Cross Street: CULLEN_CT	Location: SE
ADA ID: 361ED2D72D31	Ramp Type: BlendTrans1	Initial Pass/Fail: Fail	Overall Compliance: No
		Severity Score: 10

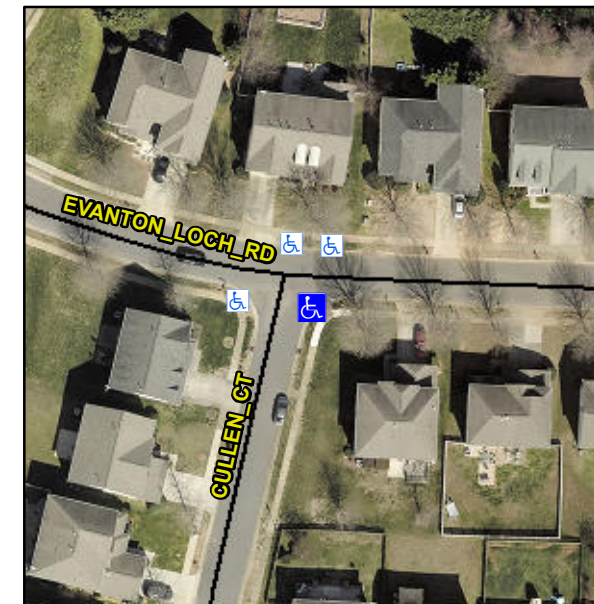
Compliance	Description	Data	Compliance	Description	Data
N/A	Ramp Length (in)	47.0	Yes	BlendTrans Slope (%)	3.9
No	Ramp Width (in)	43.5	No	BlendTrans XSlope (%)	2.5
N/A	Flare Type LT	N/A	N/A	Flare Type RT	N/A
N/A	Flare Slope LT (%)	N/A	N/A	Flare Slope RT (%)	N/A
N/A	Flare Traversable LT?	N/A	N/A	Flare Traversable RT?	N/A
N/A	Landing Length (in)	N/A	N/A	DWS Provided?	N/A
N/A	Landing Width (in)	N/A	N/A	DWS Contrast?	N/A
N/A	Landing Slope (%)	N/A	N/A	DWS Length (in)	N/A
N/A	Landing X Slope (%)	N/A	N/A	DWS Full Width?	N/A
N/A	Landing Curb? (Y/N)	N/A	N/A	DWS Offset (in)	N/A
N/A	Shared Landing?	N/A			
N/A	Gutter Ponding?	N/A	N/A	Gutter Slope (%)	N/A
N/A	Gutter Lip Ht (in)	1.0	N/A	Gutter X Slope (%)	N/A
N/A	Painted X Walk1?	No	N/A	Painted X Walk2?	No
	X Walk 1 Direction	To N		X Walk 2 Direction	To W
	X Walk 1 Width (in)	N/A		X Walk 2 Width (in)	N/A
	X Walk 1 Slope (%)	2.5		X Walk 2 Slope (%)	0.5
	X Walk 1 X Slope (%)	0.4		X Walk 2 X Slope (%)	2.1

N/A	Ramp inside XWalk1?	N/A	N/A	Ramp inside XWalk2?	N/A
	Road Slope (%)	1.1		Clear Space?	N/A
	Road X Slope (%)	1.4	N/A	Clear Space to XWalk (in)	N/A
N/A	Any Obstructions?	N/A	N/A	Storm Grate/Utility Hazard?	N/A
	Obstruction Type			Storm Grate/Utility Type	
		N/A			N/A
			Yes	Surface Condition? (G/P)	Good
			N/A	Curb Slope (%)	2.1

Remove & Replace Curb Ramp With Two New Directional Ramps or Equivalent.
