Access Compliance Report

Public Rights-of-Way

(Curb Ramps)

Intersection ID: 15389	Main Street: E_INDEPENDENCE_BV	Cross Street: WILSHIRE_PL	Location: NE
ADA ID: 36254E724197	Ramp Type: Perp	Initial Pass/Fail: Fail	Overall Compliance: No
		Severity Score: 25

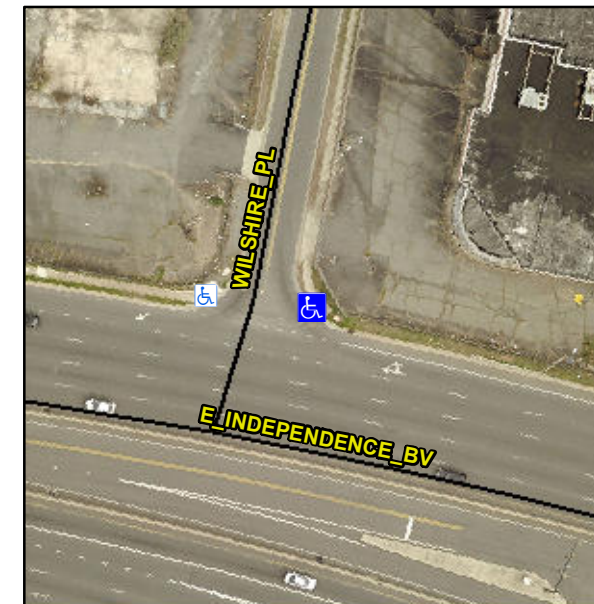
Not Found, R304.2.2, R304.5.3

Compliance	Description	Data	Compliance	Description	Data
N/A	Ramp Length (in)	88.0	No	Ramp Slope (%)	9.3
Yes	Ramp Width (in)	53.5	No	Ramp XSlope (%)	5.2
N/A	Flare Type LT	N/A	N/A	Flare Type RT	N/A
N/A	Flare Slope LT (%)	N/A	N/A	Flare Slope RT (%)	N/A
N/A	Flare Traversable LT?	N/A	N/A	Flare Traversable RT?	N/A
N/A	Landing Length (in)	N/A	N/A	DWS Provided?	N/A
N/A	Landing Width (in)	N/A	N/A	DWS Contrast?	N/A
N/A	Landing Slope (%)	N/A	N/A	DWS Length (in)	N/A
N/A	Landing X Slope (%)	N/A	N/A	DWS Full Width?	N/A
N/A	Landing Curb? (Y/N)	N/A	N/A	DWS Offset (in)	N/A
N/A	Shared Landing?	N/A			
N/A	Gutter Ponding?	N/A	N/A	Gutter Slope (%)	N/A
N/A	Gutter Lip Ht (in)	N/A	N/A	Gutter X Slope (%)	N/A
N/A	Painted X Walk1?	No	N/A	Painted X Walk2?	N/A
	X Walk 1 Direction	To NW		X Walk 2 Direction	N/A
N/A	X Walk 1 Width (in)	N/A	N/A	X Walk 2 Width (in)	N/A
	X Walk 1 Slope (%)	3.0		X Walk 2 Slope (%)	N/A
	X Walk 1 X Slope (%)	3.4		X Walk 2 X Slope (%)	N/A

N/A	Ramp inside XWalk1?	N/A	N/A	Ramp inside XWalk2?	N/A
	Road Slope (%)	N/A	N/A	Clear Space?	N/A
	Road X Slope (%)	N/A	N/A	Clear Space to XWalk (in)	N/A
N/A	Any Obstructions?	N/A	N/A	Storm Grate/Utility Hazard?	N/A
	Obstruction Type			Storm Grate/Utility Type	
		N/A			N/A
			Yes	Surface Condition? (G/P)	Good

Remove & Replace Entire Ramp.
