Access Compliance Report

Public Rights-of-Way

(Curb Ramps)

Intersection ID: 4686	Main Street: EVANSHIRE_DR	Cross Street: TRINITY_RD	Location: SW
ADA ID: 362D200CD2CE	Ramp Type: BlendTrans2	Initial Pass/Fail: Fail	Overall Compliance: No
		Severity Score: 35

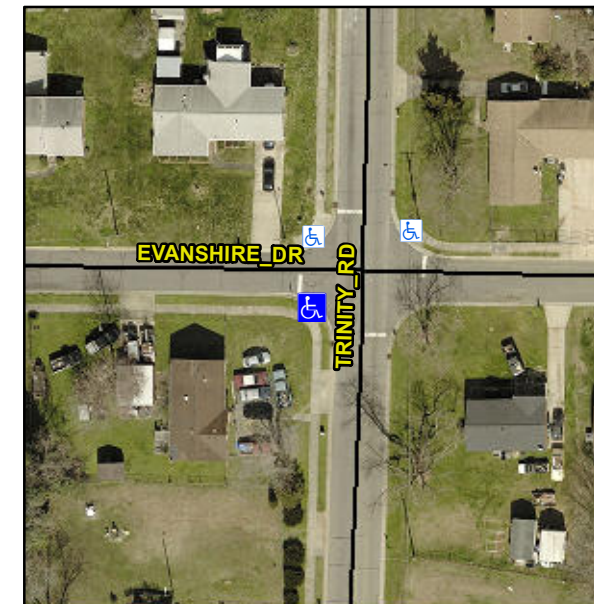
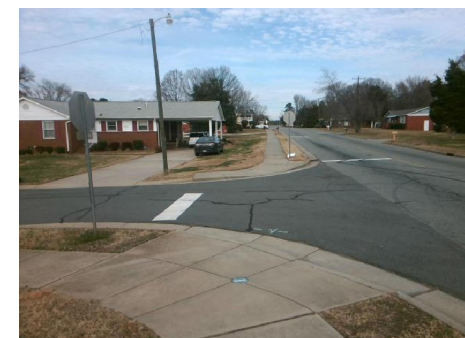
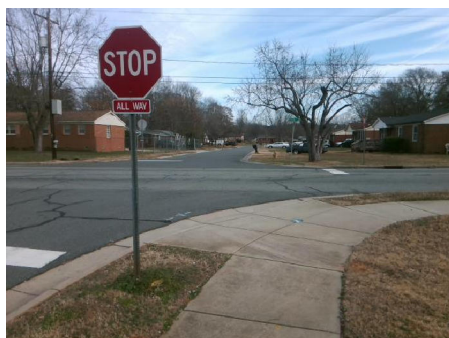
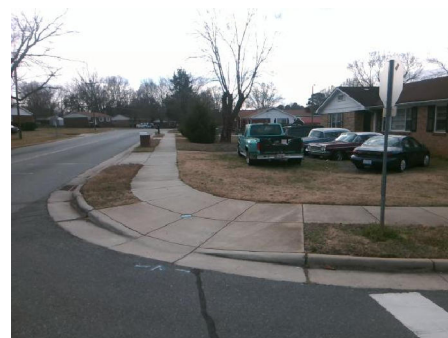
Not Found, R304.5.1

Compliance	Description	Data	Compliance	Description	Data
N/A	Ramp Length (in)	112.0	Yes	BlendTrans Slope (%)	4.2
No	Ramp Width (in)	29.0	Yes	BlendTrans XSlope (%)	1.4
N/A	Flare Type LT	N/A	N/A	Flare Type RT	N/A
N/A	Flare Slope LT (%)	N/A	N/A	Flare Slope RT (%)	N/A
N/A	Flare Traversable LT?	N/A	N/A	Flare Traversable RT?	N/A
N/A	Landing Length (in)	N/A	N/A	DWS Provided?	N/A
N/A	Landing Width (in)	N/A	N/A	DWS Contrast?	N/A
N/A	Landing Slope (%)	N/A	N/A	DWS Length (in)	N/A
N/A	Landing X Slope (%)	N/A	N/A	DWS Full Width?	N/A
N/A	Landing Curb? (Y/N)	N/A	N/A	DWS Offset (in)	N/A
N/A	Shared Landing?	N/A			
N/A	Gutter Ponding?	N/A	N/A	Gutter Slope (%)	N/A
N/A	Gutter Lip Ht (in)	N/A	N/A	Gutter X Slope (%)	N/A
N/A	Painted X Walk1?	No	N/A	Painted X Walk2?	N/A
	X Walk 1 Direction	To N		X Walk 2 Direction	N/A
	X Walk 1 Width (in)	N/A		X Walk 2 Width (in)	N/A
	X Walk 1 Slope (%)	3.0		X Walk 2 Slope (%)	N/A
	X Walk 1 X Slope (%)	1.4		X Walk 2 X Slope (%)	N/A

N/A	Ramp inside XWalk1?	N/A	N/A	Ramp inside XWalk2?	N/A
	Road Slope (%)	1.4		Clear Space?	N/A
	Road X Slope (%)	3.0	N/A	Clear Space to XWalk (in)	N/A
N/A	Any Obstructions?	N/A	N/A	Storm Grate/Utility Hazard?	N/A
	Obstruction Type			Storm Grate/Utility Type	
		N/A			N/A
			Yes	Surface Condition? (G/P)	Good
			No	Curb Slope (%)	6.2

Remove & Replace Curb Ramp With Two New Directional Ramps or Equivalent.
