Access Compliance Report

Public Rights-of-Way

(Curb Ramps)

Intersection ID: 44915	Main Street: OAKBURN_DR	Cross Street: BERRYBROOK_LN	Location: S
ADA ID: 362E356879EA	Ramp Type: PerpDiag	Initial Pass/Fail: Fail	Overall Compliance: No
		Severity Score: 10

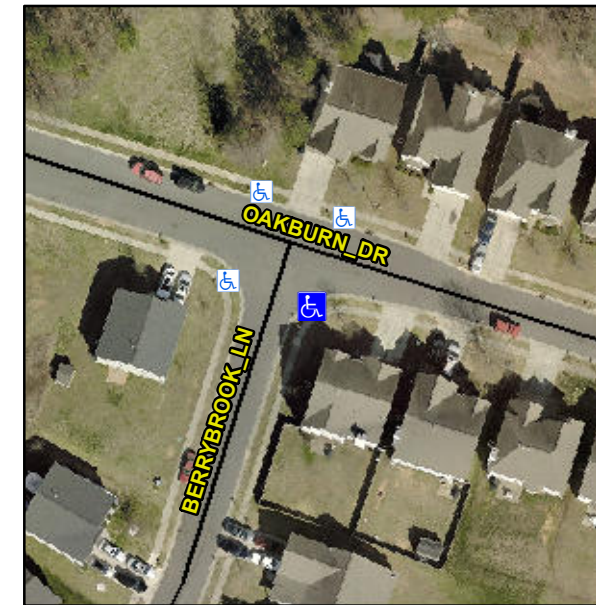
Not Found, R304.5.1, R304.5.3

Compliance	Description	Data	Compliance	Description	Data
N/A	Ramp Length (in)	48.0	Yes	Ramp Slope (%)	5.6
No	Ramp Width (in)	47.0	No	Ramp XSlope (%)	4.7
N/A	Flare Type LT	N/A	N/A	Flare Type RT	N/A
N/A	Flare Slope LT (%)	N/A	N/A	Flare Slope RT (%)	N/A
N/A	Flare Traversable LT?	N/A	N/A	Flare Traversable RT?	N/A
N/A	Landing Length (in)	N/A	N/A	DWS Provided?	N/A
N/A	Landing Width (in)	N/A	N/A	DWS Contrast?	N/A
N/A	Landing Slope (%)	N/A	N/A	DWS Length (in)	N/A
N/A	Landing X Slope (%)	N/A	N/A	DWS Full Width?	N/A
N/A	Landing Curb? (Y/N)	N/A	N/A	DWS Offset (in)	N/A
N/A	Shared Landing?	N/A			
N/A	Gutter Ponding?	N/A	N/A	Gutter Slope (%)	N/A
N/A	Gutter Lip Ht (in)	N/A	N/A	Gutter X Slope (%)	N/A
N/A	Painted X Walk1?	No	N/A	Painted X Walk2?	No
	X Walk 1 Direction	To NE		X Walk 2 Direction	To NW
N/A	X Walk 1 Width (in)	N/A	N/A	X Walk 2 Width (in)	N/A
	X Walk 1 Slope (%)	5.6		X Walk 2 Slope (%)	3.3
	X Walk 1 X Slope (%)	0.3		X Walk 2 X Slope (%)	4.4

N/A	Ramp inside XWalk1?	N/A	N/A	Ramp inside XWalk2?	N/A
	Road Slope (%)	2.4	N/A	Clear Space?	N/A
	Road X Slope (%)	3.3	N/A	Clear Space to XWalk (in)	N/A
N/A	Any Obstructions?	N/A	N/A	Storm Grate/Utility Hazard?	N/A
	Obstruction Type			Storm Grate/Utility Type	
		N/A			N/A
			Yes	Surface Condition? (G/P)	Good

Remove & Replace Curb Ramp With Two New Directional Ramps or Equivalent.
