Access Compliance Report

Public Rights-of-Way

(Curb Ramps)

Intersection ID: 6527	Main Street: FAIRES_FARM_RD	Cross Street: PAMELA_LORRAINE_DR	Location: SE
ADA ID: 362EEF8EE34F	Ramp Type: BlendTrans1	Initial Pass/Fail: Fail	Overall Compliance: No
Codes/Mitigation Info/Possible Solution		Field Measurements/Component Compliance	
Severity Score: 21.25

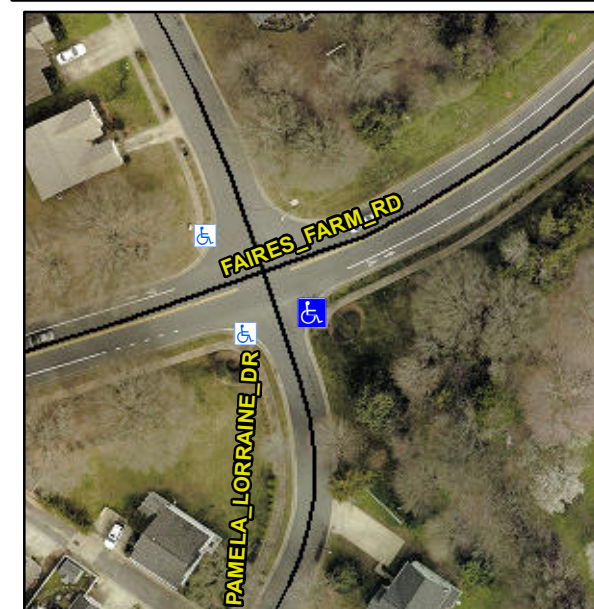
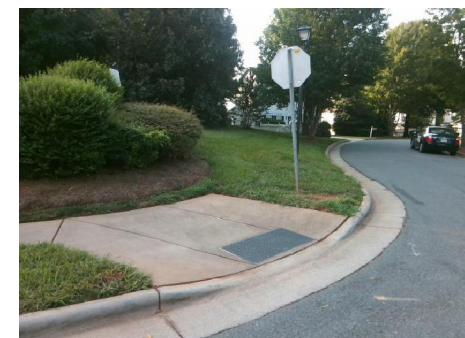
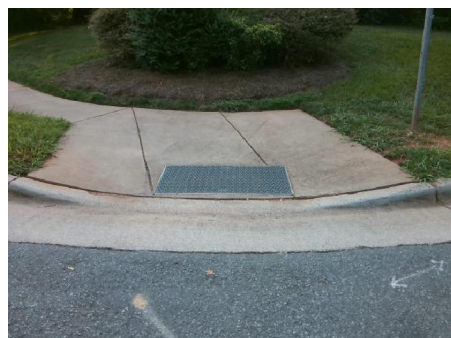
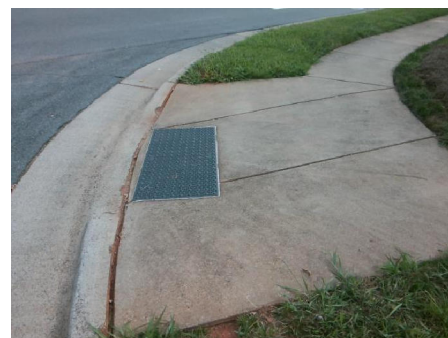
CURB GAP 3.0, NO RT SW

Not Found, R304.5.1, R304.5.3

Compliance	Description	Data	Compliance	Description	Data
N/A	Ramp Length (in)	68.5	Yes	BlendTrans Slope (%)	4.7
No	Ramp Width (in)	46.5	No	BlendTrans XSlope (%)	5.2
N/A	Flare Type LT	N/A	N/A	Flare Type RT	N/A
N/A	Flare Slope LT (%)	N/A	N/A	Flare Slope RT (%)	N/A
N/A	Flare Traversable LT?	N/A	N/A	Flare Traversable RT?	N/A
N/A	Landing Length (in)	N/A	N/A	DWS Provided?	N/A
N/A	Landing Width (in)	N/A	N/A	DWS Contrast?	N/A
N/A	Landing Slope (%)	N/A	N/A	DWS Length (in)	N/A
N/A	Landing X Slope (%)	N/A	N/A	DWS Full Width?	N/A
N/A	Landing Curb? (Y/N)	N/A	N/A	DWS Offset (in)	N/A
N/A	Shared Landing?	N/A			
N/A	Gutter Ponding?	N/A	N/A	Gutter Slope (%)	N/A
N/A	Gutter Lip Ht (in)	N/A	N/A	Gutter X Slope (%)	N/A
N/A	Painted X Walk1?	No	N/A	Painted X Walk2?	N/A
	X Walk 1 Direction	To W		X Walk 2 Direction	N/A
	X Walk 1 Width (in)	N/A		X Walk 2 Width (in)	N/A
	X Walk 1 Slope (%)	0.8		X Walk 2 Slope (%)	N/A
	X Walk 1 X Slope (%)	1.8		X Walk 2 X Slope (%)	N/A

N/A	Ramp inside XWalk1?	N/A	N/A	Ramp inside XWalk2?	N/A
	Road Slope (%)	1.8		Clear Space?	N/A
	Road X Slope (%)	0.8	N/A	Clear Space to XWalk (in)	N/A
N/A	Any Obstructions?	N/A	N/A	Storm Grate/Utility Hazard?	N/A
	Obstruction Type			Storm Grate/Utility Type	
		N/A			N/A
			Yes	Surface Condition? (G/P)	Good
			No	Curb Slope (%)	9.1

Possible Solutions:

Remove & Replace Curb Ramp With Two New Directional Ramps or Equivalent.
