Access Compliance Report

Public Rights-of-Way

(Curb Ramps)

Intersection ID: 48947	Main Street: DAVID_JENNINGS_AV	Cross Street: PEPPERPIKE_WY	Location: W
ADA ID: 363334BCCD25	Ramp Type: Perp	Initial Pass/Fail: Fail	Overall Compliance: No
		Severity Score: 25

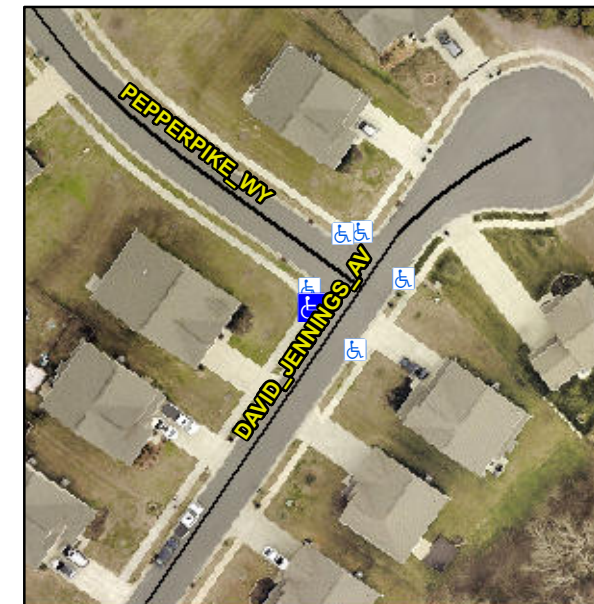
Not Found, R304.2.2, R304.5.3

Compliance	Description	Data	Compliance	Description	Data
N/A	Ramp Length (in)	57.0	No	Ramp Slope (%)	9.0
Yes	Ramp Width (in)	48.0	No	Ramp XSlope (%)	5.6
N/A	Flare Type LT	N/A	N/A	Flare Type RT	N/A
N/A	Flare Slope LT (%)	N/A	N/A	Flare Slope RT (%)	N/A
N/A	Flare Traversable LT?	N/A	N/A	Flare Traversable RT?	N/A
N/A	Landing Length (in)	N/A	N/A	DWS Provided?	N/A
N/A	Landing Width (in)	N/A	N/A	DWS Contrast?	N/A
N/A	Landing Slope (%)	N/A	N/A	DWS Length (in)	N/A
N/A	Landing X Slope (%)	N/A	N/A	DWS Full Width?	N/A
N/A	Landing Curb? (Y/N)	N/A	N/A	DWS Offset (in)	N/A
N/A	Shared Landing?	N/A			
N/A	Gutter Ponding?	N/A	N/A	Gutter Slope (%)	N/A
N/A	Gutter Lip Ht (in)	N/A	N/A	Gutter X Slope (%)	N/A
N/A	Painted X Walk1?	No	N/A	Painted X Walk2?	N/A
	X Walk 1 Direction	To SE		X Walk 2 Direction	N/A
N/A	X Walk 1 Width (in)	N/A	N/A	X Walk 2 Width (in)	N/A
	X Walk 1 Slope (%)	3.3		X Walk 2 Slope (%)	N/A
	X Walk 1 X Slope (%)	2.4		X Walk 2 X Slope (%)	N/A

N/A	Ramp inside XWalk1?	N/A	N/A	Ramp inside XWalk2?	N/A
	Road Slope (%)	N/A	N/A	Clear Space?	N/A
	Road X Slope (%)	N/A	N/A	Clear Space to XWalk (in)	N/A
N/A	Any Obstructions?	N/A	N/A	Storm Grate/Utility Hazard?	N/A
	Obstruction Type			Storm Grate/Utility Type	
		N/A			N/A
			Yes	Surface Condition? (G/P)	Good

Remove & Replace Entire Ramp.
