# Access Compliance Report

## Public Rights-of-Way

### (Curb Ramps)

Intersection ID: 28079	Main Street: DELMAHOY_DR	Cross Street: PROVIDENCE_COUNTRY_CLUB_DR	Location: SE
ADA ID: 3638CFF07EA2	Ramp Type: Perp	Initial Pass/Fail: Fail	Overall Compliance: No
Severity Score: 12.5			
Codes/Mitigation Info/Possible Solution		Field Measurements/Component Compliance

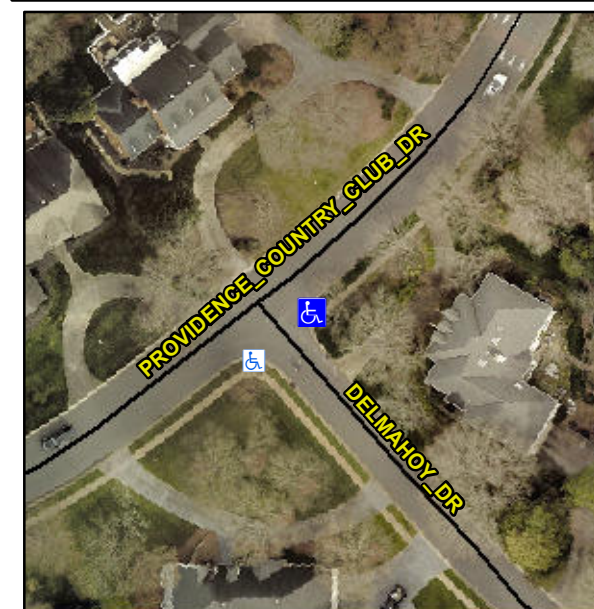
Compliance	Description	Data	Compliance	Description	Data
N/A	Ramp Length (in)	33.0	No	Ramp Slope (%)	9.8
Yes	Ramp Width (in)	48.0	Yes	Ramp XSlope (%)	0.5
N/A	Flare Type LT	N/A	N/A	Flare Type RT	N/A
N/A	Flare Slope LT (%)	N/A	N/A	Flare Slope RT (%)	N/A
N/A	Flare Traversable LT?	N/A	N/A	Flare Traversable RT?	N/A
N/A	Landing Length (in)	N/A	N/A	DWS Provided?	N/A
N/A	Landing Width (in)	N/A	N/A	DWS Contrast?	N/A
N/A	Landing Slope (%)	N/A	N/A	DWS Length (in)	N/A
N/A	Landing X Slope (%)	N/A	N/A	DWS Full Width?	N/A
N/A	Landing Curb? (Y/N)	N/A	N/A	DWS Offset (in)	N/A
N/A	Shared Landing?	N/A			
N/A	Gutter Ponding?	N/A	N/A	Gutter Slope (%)	N/A
N/A	Gutter Lip Ht (in)	N/A	N/A	Gutter X Slope (%)	N/A
N/A	Painted X Walk1?	No	N/A	Painted X Walk2?	N/A
	X Walk 1 Direction	To SW		X Walk 2 Direction	N/A
N/A	X Walk 1 Width (in)	N/A	N/A	X Walk 2 Width (in)	N/A
	X Walk 1 Slope (%)	2.0		X Walk 2 Slope (%)	N/A
	X Walk 1 X Slope (%)	0.5		X Walk 2 X Slope (%)	N/A

**Remove & Replace Entire Ramp.**

**R304.2.2**

**\$ 1850.00**

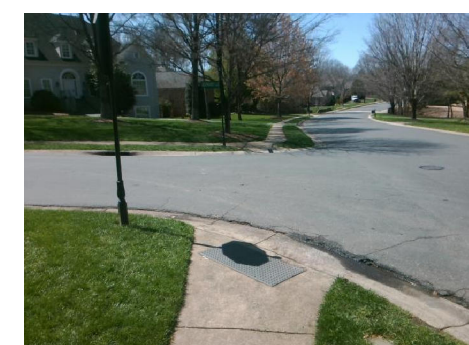
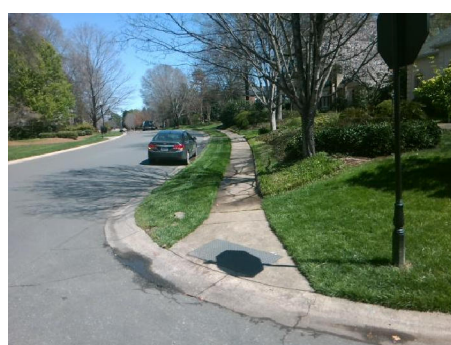
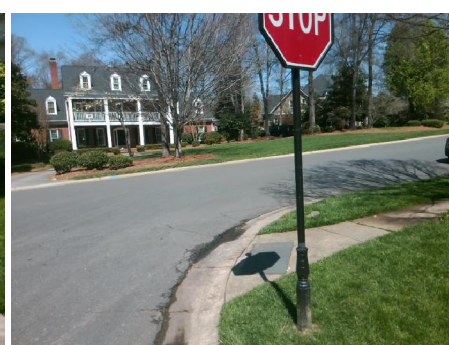
N/A	Ramp inside XWalk1?	N/A	N/A	Ramp inside XWalk2?	N/A
	Road Slope (%)	N/A	N/A	Clear Space?	N/A
	Road X Slope (%)	N/A	N/A	Clear Space to XWalk (in)	N/A
N/A	Any Obstructions?	N/A	N/A	Storm Grate/Utility Hazard?	N/A
	Obstruction Type			Storm Grate/Utility Type	
		N/A			N/A
		Yes		Surface Condition? (G/P)	Good
