# Access Compliance Report

## Public Rights-of-Way

### (Curb Ramps)

| Intersection ID: 9283 | Main Street: FERNDAL PL | Cross Street: THE PLAZA | Location: | S |

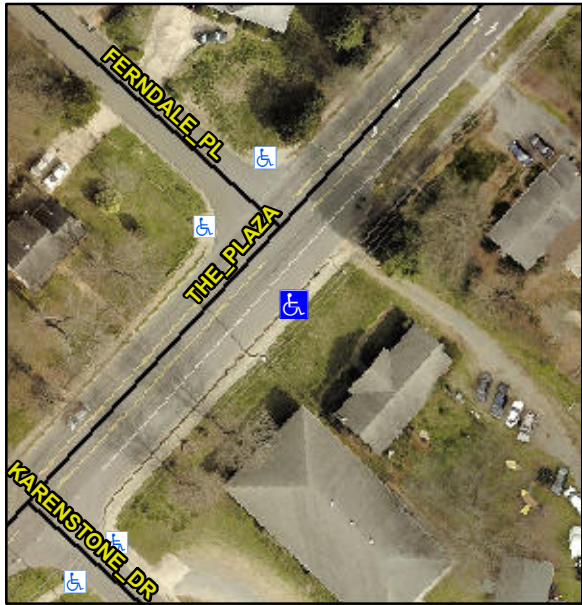
| ADA ID: 363D68976E76 | Ramp Type: Perp | Initial Pass/Fail: Fail | Overall Compliance: No | Severity Score: 8.75 |

| Codes/Mitigation Info/Possible Solution | | | Field Measurements/Component Compliance | | | | | |
|---|---|---|---|---|---|---|---|---|
| | | | No | Ramp Width (in) | 47.5 | Yes | Ramp XSlope (%) | 0.1 |

| Codes/Mitigation Info/Possible Solution | | | Field Measurements/Component Compliance | | | | | |
|---|---|---|---|---|---|---|---|---|
| | Remove & Replace Entire Ramp. | | N/A | Ramp Length (in) | 70.5 | Yes | Ramp Slope (%) | 7.1 |
| Total Cost: | | \$ 1850.00 | | | | | | |
