Access Compliance Report Public Rights-of-Way (Curb Ramps)

0					Leveller	0)1/	
Intersection ID: 18792 Main St	Main Street: BARCLAY_DOWNS_DR		Cross Street: SAGAMORE_RD			Location:	SW		
ADA ID: 36403A408C8C Ramp T	Ramp Type: PerpDiag		nitial Pass/Fail: Fail Overall Compliance			ice: N	o Severity Score:	12.5	
Codes/Mitigation Info/Possible Solution			Field Measurements/Component Compliance						
	Possible Solutions:	<u>c</u>	Compliance Description		Data Compliance Description		liance Description	Data	
	Remove & Replace Curb Ramp W	ith N	I/A	Ramp Length (in)	54.0	No	Ramp Slope (%)	10.1	
	Two New Directional Ramps or Equivalent.		'es	Ramp Width (in)	48.0	Yes	Ramp XSlope (%)	1.2	
		Ν	/ A	Flare Type LT	N/A	N/A	Flare Type RT	N/A	
		Ν	I/A	Flare Slope LT (%)	N/A	N/A	Flare Slope RT (%)	N/A	
		Ν	I/A	Flare Traversable LT?	N/A	N/A	Flare Traversable RT?	N/A	
		Ν	I/A	Landing Length (in)	N/A	N/A	DWS Provided?	N/A	
	Surveyor Notes:	Ν	I/A	Landing Width (in)	N/A	N/A	DWS Contrast?	N/A

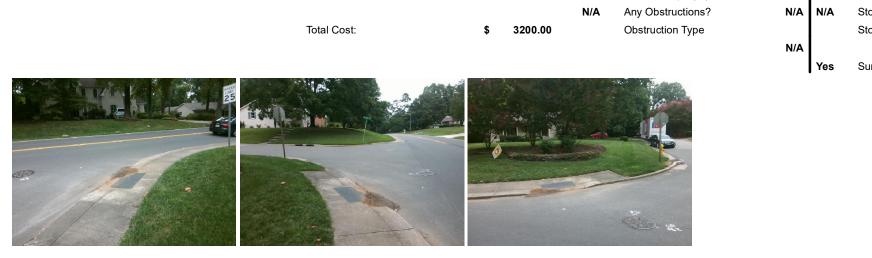
N/A	Ν	I/A	Landing Slope (%)	N/A	N/A	DWS Length (in)	N/A	
		Ν	I/A	Landing X Slope (%)	N/A	N/A	DWS Full Width?	N/A	
		Ν	I/A	Landing Curb? (Y/N)	N/A	N/A	DWS Offset (in)	N/A	
		Ν	I/A	Shared Landing?	N/A				
	PROW/ADA:	Ν	I/A	Gutter Ponding?	Yes	N/A	Gutter Slope (%)	N/A	
	Not Found, R304.2.2	N	/ A	Gutter Lip Ht (in)	N/A	N/A	Gutter X Slope (%)	N/A	
		Ν	I/A	Painted X Walk1?	No	N/A	Painted X Walk2?	No	
				X Walk 1 Direction	To E		X Walk 2 Direction	To NE	
A CARLEN AND AND AND AND AND AND AND AND AND AN		Ν	I/A	X Walk 1 Width (in)	N/A	N/A	X Walk 2 Width (in)	N/A	
Street 1 Name BARCLAY DOWNS DR	_			X Walk 1 Slope (%)	4.7		X Walk 2 Slope (%)	2.9	
Stop Condition-Street 2 None				X Walk 1 X Slope (%)	0.3		X Walk 2 X Slope (%)	1.2	
Street 2 Name SAGAMORE RD		Ν	I/A	Ramp inside XWalk1?	N/A	N/A	Ramp inside XWalk2?	N/A	
Stop Condition-Street 1 StopSign				Road Slope (%)	0.3	N/A	Clear Space?	N/A	
				Road X Slope (%)	3.1	N/A	Clear Space to XWalk (in)	N/A
