# Access Compliance Report

## Public Rights-of-Way

### (Curb Ramps)

Intersection ID: 2768	Main Street: BELL'S_MILL_DR	Cross Street: CRAIL_CT	Location: SE
ADA ID: 3645E22DD4BF	Ramp Type: BlendTrans1	Initial Pass/Fail: Pass	Overall Compliance: No
		Severity Score: 10

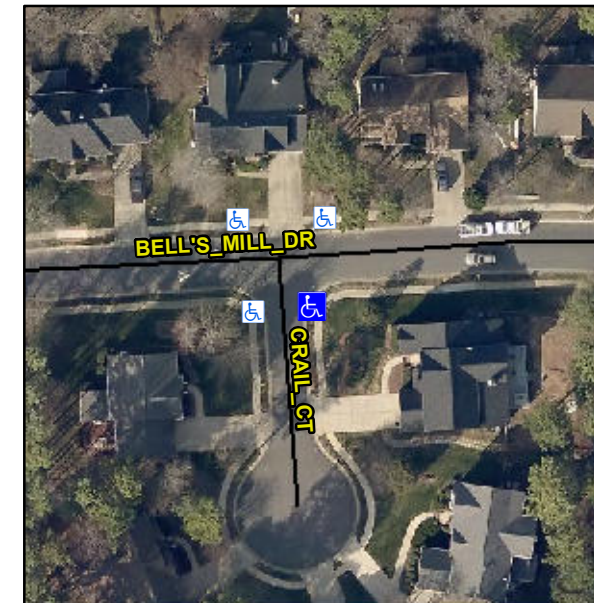
**Not Found, R304.2.1, R304.2.2-Perp, R304.3.2-Para, R305**

Compliance	Description	Data	Compliance	Description	Data
N/A	Ramp Length (in)	47.0	Yes	BlendTrans Slope (%)	1.9
Yes	Ramp Width (in)	120.0	Yes	BlendTrans XSlope (%)	1.4
N/A	Flare Type LT	Sloped	N/A	Flare Type RT	Sloped
N/A	Flare Slope LT (%)	0.5	N/A	Flare Slope RT (%)	3.7
N/A	Flare Traversable LT?	No	N/A	Flare Traversable RT?	No
No	Landing Length (in)	47.0	No	DWS Provided?	No
Yes	Landing Width (in)	120.0	N/A	DWS Contrast?	No
No	Landing Slope (%)	2.8	N/A	DWS Length (in)	N/A
Yes	Landing X Slope (%)	1.5	N/A	DWS Full Width?	No
N/A	Landing Curb? (Y/N)	No	N/A	DWS Offset (in)	N/A
N/A	Shared Landing?	No			
Yes	Gutter Ponding?	No	Yes	Gutter Slope (%)	3.2
Yes	Gutter Lip Ht (in)	0.0	Yes	Gutter X Slope (%)	1.8
N/A	Painted X Walk1?	No	N/A	Painted X Walk2?	No
	X Walk 1 Direction	To N		X Walk 2 Direction	To W
	X Walk 1 Width (in)	N/A		X Walk 2 Width (in)	N/A
	X Walk 1 Slope (%)	2.1		X Walk 2 Slope (%)	5.3
	X Walk 1 X Slope (%)	3.9		X Walk 2 X Slope (%)	0.7

N/A	Ramp inside XWalk1?	N/A	N/A	Ramp inside XWalk2?	N/A
	Road Slope (%)	3.1		Clear Space?	Yes
	Road X Slope (%)	4.4	N/A	Clear Space to XWalk (in)	N/A
Yes	Any Obstructions?	No	Yes	Storm Grate/Utility Hazard?	No
	Obstruction Type			Storm Grate/Utility Type	
		N/A			N/A
			Yes	Surface Condition? (G/P)	Good
			No	Curb Slope (%)	5.6

**Remove & Replace Curb Ramp With Two New Directional Ramps or Equivalent.**
