Intersection ID: 17430	Main Street: W_WOODLAWN_RD	Cross Street: WALLINGFORD_ST	Location:	NW
ADA ID: 3648A68D1942	Ramp Type: PerpDiag	Initial Pass/Fail: Fail	Overall Compliance: No	Severity Score: 13.75

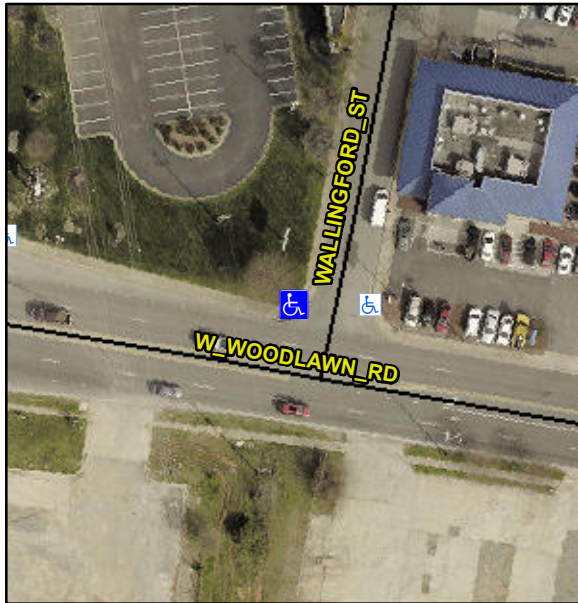
**Not Found, R304.2.2, R304.5.3**

Compliance	Description	Data	Compliance	Description	Data
N/A	Ramp Length (in)	60.0	No	Ramp Slope (%)	10.8
Yes	Ramp Width (in)	48.0	No	Ramp XSlope (%)	3.5
N/A	Flare Type LT	N/A	N/A	Flare Type RT	N/A
N/A	Flare Slope LT (%)	N/A	N/A	Flare Slope RT (%)	N/A
N/A	Flare Traversable LT?	N/A	N/A	Flare Traversable RT?	N/A
N/A	Landing Length (in)	N/A	N/A	DWS Provided?	N/A
N/A	Landing Width (in)	N/A	N/A	DWS Contrast?	N/A
N/A	Landing Slope (%)	N/A	N/A	DWS Length (in)	N/A
N/A	Landing X Slope (%)	N/A	N/A	DWS Full Width?	N/A
N/A	Landing Curb? (Y/N)	N/A	N/A	DWS Offset (in)	N/A
N/A	Shared Landing?	N/A			
N/A	Gutter Ponding?	N/A	N/A	Gutter Slope (%)	N/A
N/A	Gutter Lip Ht (in)	N/A	N/A	Gutter X Slope (%)	N/A
N/A	Painted X Walk1?	No	N/A	Painted X Walk2?	No
	X Walk 1 Direction	To SW		X Walk 2 Direction	To E
N/A	X Walk 1 Width (in)	N/A	N/A	X Walk 2 Width (in)	N/A
	X Walk 1 Slope (%)	1.4		X Walk 2 Slope (%)	0.4
	X Walk 1 X Slope (%)	0.2		X Walk 2 X Slope (%)	2.4

N/A	Ramp inside XWalk1?	N/A	N/A	Ramp inside XWalk2?	N/A
	Road Slope (%)	1.7	N/A	Clear Space?	N/A
	Road X Slope (%)	0.8	N/A	Clear Space to XWalk (in)	N/A
N/A	Any Obstructions?	N/A	N/A	Storm Grate/Utility Hazard?	N/A
	Obstruction Type			Storm Grate/Utility Type	
		N/A			N/A
			Yes	Surface Condition? (G/P)	Good

**Remove & Replace Curb Ramp With Two New Directional Ramps or Equivalent.**
