# Access Compliance Report

## Public Rights-of-Way

### (Curb Ramps)

Intersection ID: 3003	Main Street: GOLDEN_POND_DR	Cross Street: WOODFIRE_RD	Location: SE
ADA ID: 364A4E855631	Ramp Type: Perp	Initial Pass/Fail: Fail	Overall Compliance: No
Codes/Mitigation Info/Possible Solution			Severity Score: 50
			Field Measurements/Component Compliance

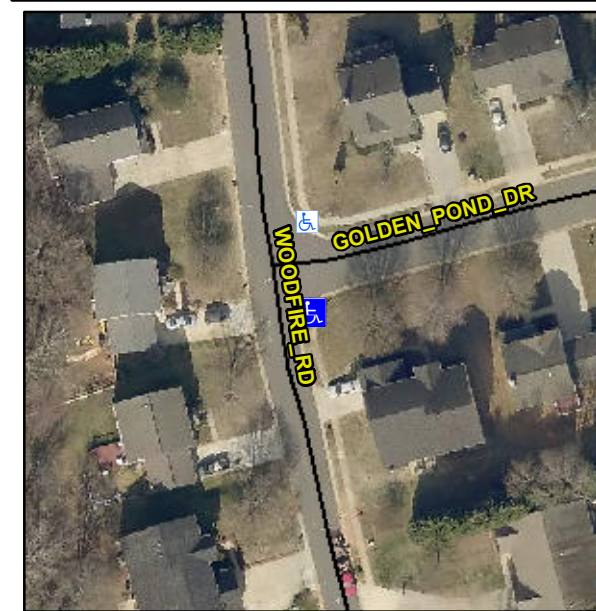
Compliance	Description	Data	Compliance	Description	Data
N/A	Ramp Length (in)	47.0	No	Ramp Slope (%)	15.1
Yes	Ramp Width (in)	48.0	No	Ramp XSlope (%)	12.1
N/A	Flare Type LT	N/A	N/A	Flare Type RT	N/A
N/A	Flare Slope LT (%)	N/A	N/A	Flare Slope RT (%)	N/A
N/A	Flare Traversable LT?	N/A	N/A	Flare Traversable RT?	N/A
N/A	Landing Length (in)	N/A	N/A	DWS Provided?	N/A
N/A	Landing Width (in)	N/A	N/A	DWS Contrast?	N/A
N/A	Landing Slope (%)	N/A	N/A	DWS Length (in)	N/A
N/A	Landing X Slope (%)	N/A	N/A	DWS Full Width?	N/A
N/A	Landing Curb? (Y/N)	N/A	N/A	DWS Offset (in)	N/A
N/A	Shared Landing?	N/A			
N/A	Gutter Ponding?	N/A	N/A	Gutter Slope (%)	N/A
N/A	Gutter Lip Ht (in)	N/A	N/A	Gutter X Slope (%)	N/A
N/A	Painted X Walk1?	No	N/A	Painted X Walk2?	N/A
	X Walk 1 Direction	To N		X Walk 2 Direction	N/A
N/A	X Walk 1 Width (in)	N/A	N/A	X Walk 2 Width (in)	N/A
	X Walk 1 Slope (%)	4.6		X Walk 2 Slope (%)	N/A
	X Walk 1 X Slope (%)	6.1		X Walk 2 X Slope (%)	N/A

N/A	Ramp inside XWalk1?	N/A	N/A	Ramp inside XWalk2?	N/A
	Road Slope (%)	N/A	N/A	Clear Space?	N/A
	Road X Slope (%)	N/A	N/A	Clear Space to XWalk (in)	N/A
N/A	Any Obstructions?	N/A	N/A	Storm Grate/Utility Hazard?	N/A
	Obstruction Type			Storm Grate/Utility Type	
		N/A			N/A
			Yes	Surface Condition? (G/P)	Good

Possible Solutions:

**Remove & Replace Entire Ramp.**

PROW/ADA:

**R304.2.2, R304.5.3**

Total Cost: \$ 1850.00
