Access Compliance Report

Public Rights-of-Way

(Curb Ramps)

Intersection ID: 8266	Main Street: CATHERINE_SIMMONS_AV	Cross Street: MADRID_ST	Location: NW
ADA ID: 36521BD9FC3A	Ramp Type: PerpDiag	Initial Pass/Fail: Fail	Overall Compliance: No
Severity Score: 21.25			
Codes/Mitigation Info/Possible Solution		Field Measurements/Component Compliance

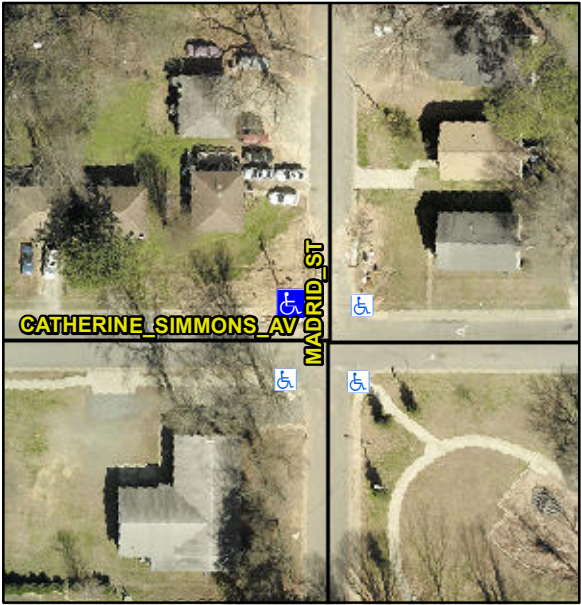
Possible Solutions:		Compliance	Description	Data	Compliance	Description	Data
		Remove & Replace Curb Ramp With Two New Directional Ramps or Equivalent.		N/A	Ramp Length (in)	42.0	Yes	Ramp Slope (%)	5.5
		Surveyor Notes:		No	Ramp Width (in)	47.5	No	Ramp XSlope (%)	6.3
		N/A		N/A	Flare Type LT	N/A	N/A	Flare Type RT	N/A
		PROW/ADA:		N/A	Flare Slope LT (%)	N/A	N/A	Flare Slope RT (%)	N/A
		Not Found, R304.5.1, R304.5.3		N/A	Flare Traversable LT?	N/A	N/A	Flare Traversable RT?	N/A
				N/A	Landing Length (in)	N/A	N/A	DWS Provided?	N/A
				N/A	Landing Width (in)	N/A	N/A	DWS Contrast?	N/A
				N/A	Landing Slope (%)	N/A	N/A	DWS Length (in)	N/A
				N/A	Landing X Slope (%)	N/A	N/A	DWS Full Width?	N/A
				N/A	Landing Curb? (Y/N)	N/A	N/A	DWS Offset (in)	N/A
				N/A	Shared Landing?	N/A			
				N/A	Gutter Ponding?	N/A	N/A	Gutter Slope (%)	N/A
				N/A	Gutter Lip Ht (in)	N/A	N/A	Gutter X Slope (%)	N/A
				N/A	Painted X Walk1?	No	N/A	Painted X Walk2?	No

X Walk 1 Direction	To S		X Walk 2 Direction	To E
				N/A	X Walk 1 Width (in)	N/A	N/A	X Walk 2 Width (in)	N/A
					X Walk 1 Slope (%)	2.9		X Walk 2 Slope (%)	2.8
					X Walk 1 X Slope (%)	3.3		X Walk 2 X Slope (%)	0.5
				N/A	Ramp inside XWalk1?	N/A	N/A	Ramp inside XWalk2?	N/A
					Road Slope (%)	4.1	N/A	Clear Space?	N/A
					Road X Slope (%)	0.9	N/A	Clear Space to XWalk (in)	N/A
				N/A	Any Obstructions?	N/A	N/A	Storm Grate/Utility Hazard?	N/A
					Obstruction Type			Storm Grate/Utility Type	
							N/A		N/A
							Yes	Surface Condition? (G/P)	Good
