# Access Compliance Report

## Public Rights-of-Way

| Intersection ID: 15133 | Main Street: PERIMETER_POINTE_PY | Cross Street: W_TYVOLA_RD | Location: SE |
| ADA ID: 365F7BBEBAC0 | Ramp Type: Para | Initial Pass/Fail: Pass | Overall Compliance: No |

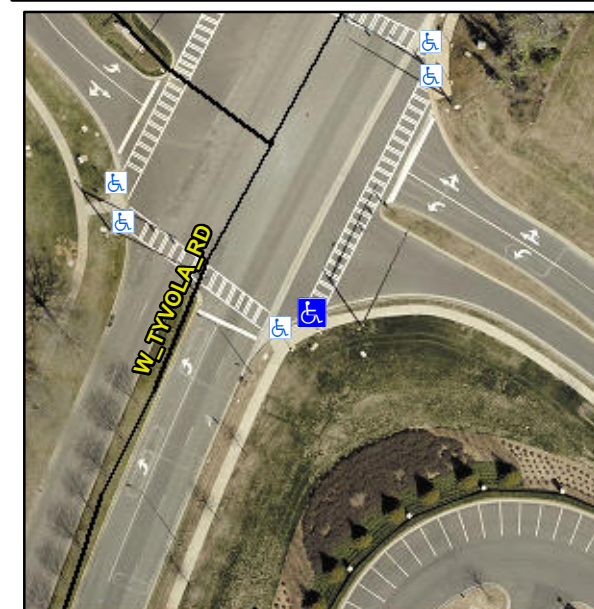
| Severity Score: 5 | | | |

**Not Found, R304.2.1, R305.2,  
R304.5.4**

| Compliance | Description | Data | Compliance | Description | Data |
|---|---|---|---|---|---|
| No | Landing Width (in) | 47.5 | Yes | DWS Contrast? | Yes |
| N/A | Landing Curb? (Y/N) | No | No | DWS Offset (in) | 5.0 |
| Yes | Gutter Ponding? | No | No | Gutter Slope (%) | 6.7 |
| | | | Replace | Curb Slope (%) | 9.6 |

**Remove & Replace Entire Ramp.  
Remove & Replace Gutter.**

Total Cost: \$ 2350.00
