# Access Compliance Report

## Public Rights-of-Way

### (Curb Ramps)

Intersection ID: 28079	Main Street: DELMAHOY_DR	Cross Street: PROVIDENCE_COUNTRY_CLUB_DR	Location: SW
ADA ID: 3661161D5A19	Ramp Type: Perp	Initial Pass/Fail: Fail	Overall Compliance: No
Severity Score: 12.5			
Codes/Mitigation Info/Possible Solution		Field Measurements/Component Compliance

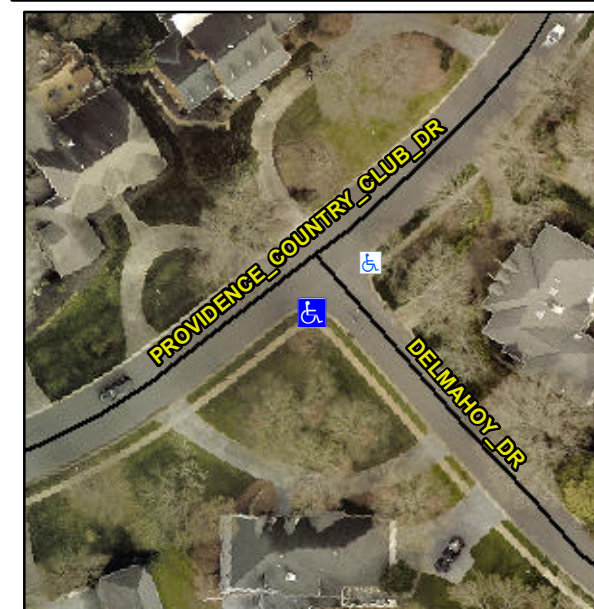
**Not Found, R304.5.3**

Compliance	Description	Data	Compliance	Description	Data
N/A	Ramp Length (in)	54.0	Yes	Ramp Slope (%)	6.4
Yes	Ramp Width (in)	48.0	No	Ramp XSlope (%)	6.9
N/A	Flare Type LT	N/A	N/A	Flare Type RT	N/A
N/A	Flare Slope LT (%)	N/A	N/A	Flare Slope RT (%)	N/A
N/A	Flare Traversable LT?	N/A	N/A	Flare Traversable RT?	N/A
N/A	Landing Length (in)	N/A	N/A	DWS Provided?	N/A
N/A	Landing Width (in)	N/A	N/A	DWS Contrast?	N/A
N/A	Landing Slope (%)	N/A	N/A	DWS Length (in)	N/A
N/A	Landing X Slope (%)	N/A	N/A	DWS Full Width?	N/A
N/A	Landing Curb? (Y/N)	N/A	N/A	DWS Offset (in)	N/A
N/A	Shared Landing?	N/A			
N/A	Gutter Ponding?	N/A	N/A	Gutter Slope (%)	N/A
N/A	Gutter Lip Ht (in)	N/A	N/A	Gutter X Slope (%)	N/A
N/A	Painted X Walk1?	No	N/A	Painted X Walk2?	N/A
	X Walk 1 Direction	To NE		X Walk 2 Direction	N/A
N/A	X Walk 1 Width (in)	N/A	N/A	X Walk 2 Width (in)	N/A
	X Walk 1 Slope (%)	4.5		X Walk 2 Slope (%)	N/A
	X Walk 1 X Slope (%)	1.2		X Walk 2 X Slope (%)	N/A

N/A	Ramp inside XWalk1?	N/A	N/A	Ramp inside XWalk2?	N/A
	Road Slope (%)	N/A	N/A	Clear Space?	N/A
	Road X Slope (%)	N/A	N/A	Clear Space to XWalk (in)	N/A
N/A	Any Obstructions?	N/A	N/A	Storm Grate/Utility Hazard?	N/A
	Obstruction Type			Storm Grate/Utility Type	
		N/A			N/A
		Yes		Surface Condition? (G/P)	Good

Possible Solutions:

**Remove & Replace Entire Ramp.**

Total Cost: \$ 1850.00
