Access Compliance Report

Public Rights-of-Way

(Curb Ramps)

Intersection ID: 10034609	Main Street: PLANTATION_CENTER_DR	Cross Street: N/A	Location: N
ADA ID: 36656EAF316	Ramp Type: Para	Initial Pass/Fail: Fail	Overall Compliance: No
Codes/Mitigation Info/Possible Solution		Field Measurements/Component Compliance	
Severity Score: 12.5

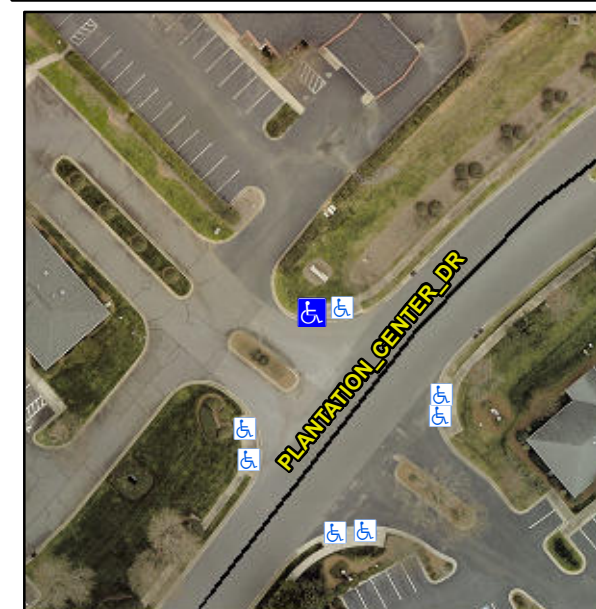
R304.3.2

Compliance	Description	Data	Compliance	Description	Data
N/A	Ramp Length LT (in)	60.0	N/A	Ramp Length RT (in)	60.0
Yes	Ramp Width LT (in)	96.0	Yes	Ramp Width RT (in)	96.0
No	Ramp Slope LT (%)	8.6	Yes	Ramp Slope RT (%)	5.9
Yes	Ramp XSlope LT (%)	2.0	Yes	Ramp XSlope RT (%)	1.6
N/A	Landing Length (in)	N/A	N/A	DWS Provided?	N/A
N/A	Landing Width (in)	N/A	N/A	DWS Contrast?	N/A
N/A	Landing Slope (%)	N/A	N/A	DWS Length (in)	N/A
N/A	Landing X Slope (%)	N/A	N/A	DWS Full Width?	N/A
N/A	Landing Curb? (Y/N)	N/A	N/A	DWS Offset (in)	N/A
N/A	Shared Landing?	N/A			
N/A	Gutter Ponding?	N/A	N/A	Gutter Slope (%)	N/A
N/A	Gutter Lip Ht (in)	N/A	N/A	Gutter X Slope (%)	N/A
N/A	Painted X Walk1?	No	N/A	Painted X Walk2?	N/A
	X Walk 1 Direction	To SW		X Walk 2 Direction	N/A
N/A	X Walk 1 Width (in)	N/A	N/A	X Walk 2 Width (in)	N/A
	X Walk 1 Slope (%)	1.8		X Walk 2 Slope (%)	N/A
	X Walk 1 X Slope (%)	0.1		X Walk 2 X Slope (%)	N/A
N/A	Ramp inside XWalk1?	N/A	N/A	Ramp inside XWalk2?	N/A

Road Slope (%)	N/A	N/A	Clear Space?	N/A
	Road X Slope (%)	N/A	N/A	Clear Space to XWalk (in)	N/A
N/A	Any Obstructions?	N/A	N/A	Storm Grate/Utility Hazard?	N/A
	Obstruction Type			Storm Grate/Utility Type	
		N/A			N/A
			Yes	Surface Condition? (G/P)	Good
			N/A	Curb Slope (%)	7.3

Possible Solutions:

Remove & Replace Entire Ramp.
