Access Compliance Report

Public Rights-of-Way

(Curb Ramps)

Intersection ID: 24095	Main Street: LIVINGSTON_MILL_RD	Cross Street: RED_WINE_CT	Location: NW
ADA ID: 366B3BC322BC	Ramp Type: PerpDiag	Initial Pass/Fail: Fail	Overall Compliance: No
Severity Score: 17.5			
Codes/Mitigation Info/Possible Solution		Field Measurements/Component Compliance

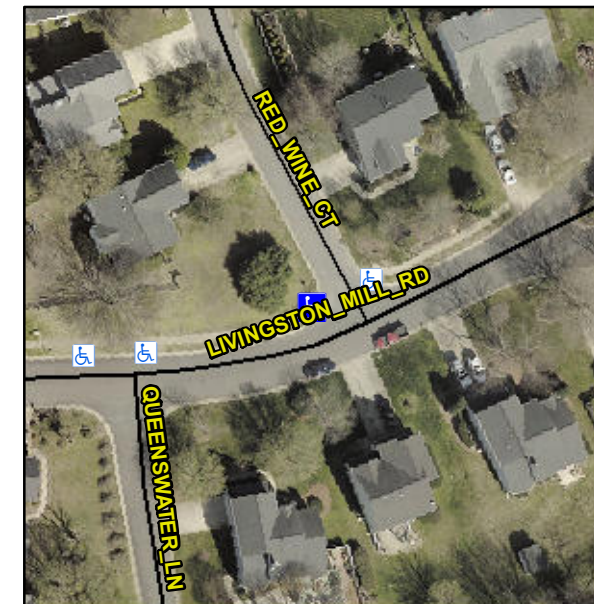
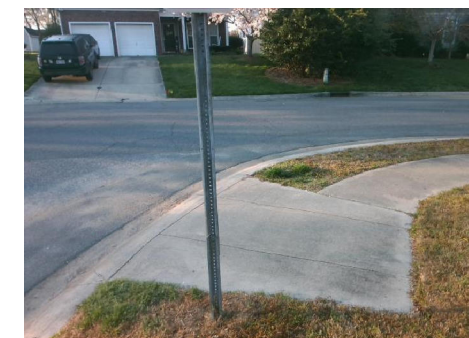
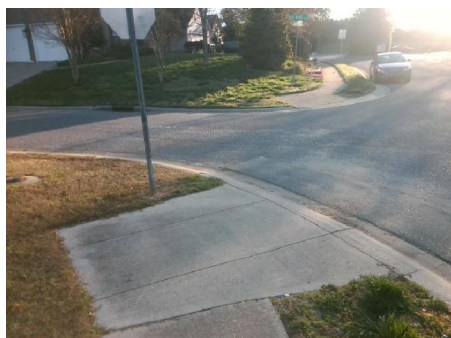
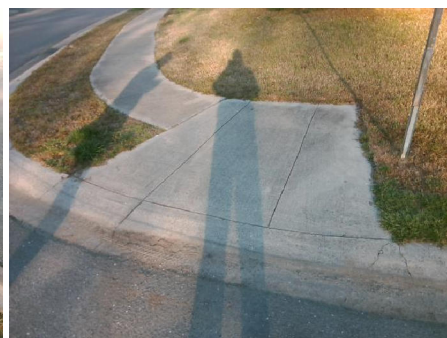
Not Found, R304.5.1

Compliance	Description	Data	Compliance	Description	Data
N/A	Ramp Length (in)	97.0	Yes	Ramp Slope (%)	7.9
No	Ramp Width (in)	35.0	Yes	Ramp XSlope (%)	0.5
N/A	Flare Type LT	N/A	N/A	Flare Type RT	N/A
N/A	Flare Slope LT (%)	N/A	N/A	Flare Slope RT (%)	N/A
N/A	Flare Traversable LT?	N/A	N/A	Flare Traversable RT?	N/A
N/A	Landing Length (in)	N/A	N/A	DWS Provided?	N/A
N/A	Landing Width (in)	N/A	N/A	DWS Contrast?	N/A
N/A	Landing Slope (%)	N/A	N/A	DWS Length (in)	N/A
N/A	Landing X Slope (%)	N/A	N/A	DWS Full Width?	N/A
N/A	Landing Curb? (Y/N)	N/A	N/A	DWS Offset (in)	N/A
N/A	Shared Landing?	N/A			
N/A	Gutter Ponding?	N/A	N/A	Gutter Slope (%)	N/A
N/A	Gutter Lip Ht (in)	N/A	N/A	Gutter X Slope (%)	N/A
N/A	Painted X Walk1?	No	N/A	Painted X Walk2?	No
	X Walk 1 Direction	To S		X Walk 2 Direction	To E
N/A	X Walk 1 Width (in)	N/A	N/A	X Walk 2 Width (in)	N/A
	X Walk 1 Slope (%)	0.1		X Walk 2 Slope (%)	2.0
	X Walk 1 X Slope (%)	0.6		X Walk 2 X Slope (%)	1.1

N/A	Ramp inside XWalk1?	N/A	N/A	Ramp inside XWalk2?	N/A
	Road Slope (%)	0.5	N/A	Clear Space?	N/A
	Road X Slope (%)	1.7	N/A	Clear Space to XWalk (in)	N/A
N/A	Any Obstructions?	N/A	N/A	Storm Grate/Utility Hazard?	N/A
	Obstruction Type			Storm Grate/Utility Type	
		N/A			N/A
		Yes		Surface Condition? (G/P)	Good

Remove & Replace Curb Ramp With Two New Directional Ramps or Equivalent.

Total Cost: \$ 3200.00
