# Access Compliance Report

## Public Rights-of-Way

### (Curb Ramps)

Intersection ID: 3070	Main Street: MT_HOLLY-HUNTERSVILLE_RD	Cross Street: WALDEN_RIDGE_DR	Location:	N/A
ADA ID: 366EAEB6EDCB	Ramp Type: Perp	Initial Pass/Fail: Fail	Overall Compliance: No	Severity Score: 25
Codes/Mitigation Info/Possible Solution		Field Measurements/Component Compliance

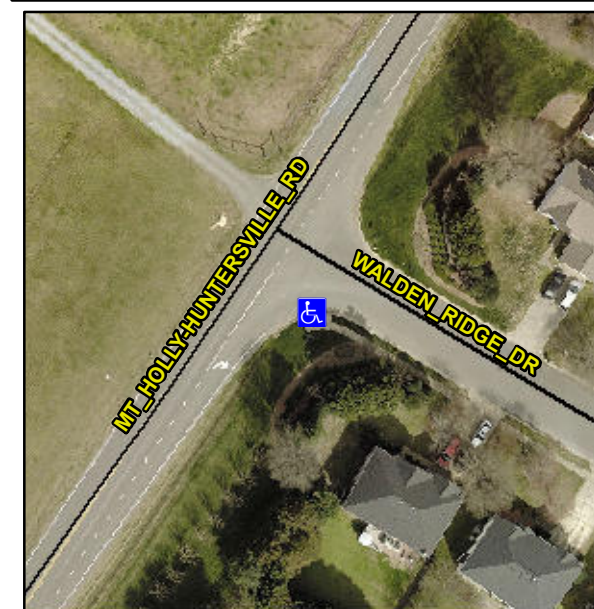
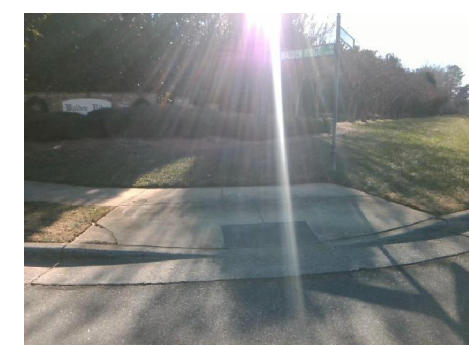
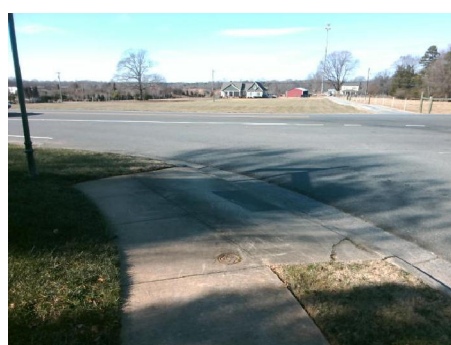
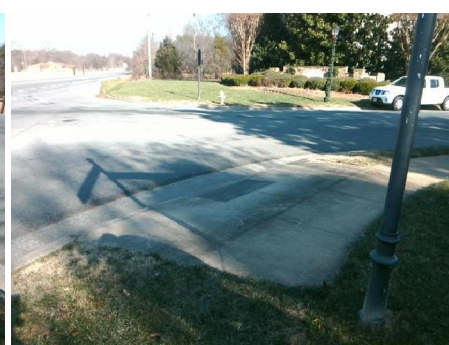
Compliance	Description	Data	Compliance	Description	Data
N/A	Ramp Length (in)	58.0	No	Ramp Slope (%)	12.3
Yes	Ramp Width (in)	48.0	Yes	Ramp XSlope (%)	1.9
N/A	Flare Type LT	N/A	N/A	Flare Type RT	N/A
N/A	Flare Slope LT (%)	N/A	N/A	Flare Slope RT (%)	N/A
N/A	Flare Traversable LT?	N/A	N/A	Flare Traversable RT?	N/A
N/A	Landing Length (in)	N/A	N/A	DWS Provided?	N/A
N/A	Landing Width (in)	N/A	N/A	DWS Contrast?	N/A
N/A	Landing Slope (%)	N/A	N/A	DWS Length (in)	N/A
N/A	Landing X Slope (%)	N/A	N/A	DWS Full Width?	N/A
N/A	Landing Curb? (Y/N)	N/A	N/A	DWS Offset (in)	N/A
N/A	Shared Landing?	N/A			
N/A	Gutter Ponding?	N/A	N/A	Gutter Slope (%)	N/A
N/A	Gutter Lip Ht (in)	N/A	N/A	Gutter X Slope (%)	N/A
N/A	Painted X Walk1?	No	N/A	Painted X Walk2?	N/A
	X Walk 1 Direction	To W		X Walk 2 Direction	N/A
N/A	X Walk 1 Width (in)	N/A	N/A	X Walk 2 Width (in)	N/A
	X Walk 1 Slope (%)	0.9		X Walk 2 Slope (%)	N/A
	X Walk 1 X Slope (%)	4.6		X Walk 2 X Slope (%)	N/A

N/A	Ramp inside XWalk1?	N/A	N/A	Ramp inside XWalk2?	N/A
	Road Slope (%)	4.6	N/A	Clear Space?	N/A
	Road X Slope (%)	0.9	N/A	Clear Space to XWalk (in)	N/A
N/A	Any Obstructions?	N/A	N/A	Storm Grate/Utility Hazard?	N/A
	Obstruction Type			Storm Grate/Utility Type	
		N/A			N/A
			Yes	Surface Condition? (G/P)	Good

**Remove & Replace Entire Ramp.**

**\$ 1850.00**
