Access Compliance Report Public Rights-of-Way (Curb Ramps)

Intersection ID: 51356 Main Street: BRENTMOOR DR **Cross Street: PEARL ST** Location: **Overall Compliance: No** ADA ID: 36787FAA2AAB Ramp Type: BlendTrans1 Initial Pass/Fail: Pass Severity Score: 10.25

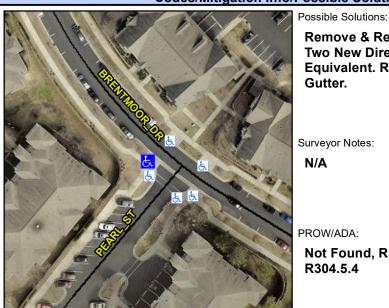
Comp	liance Description	Data	Comp	oliance Description	Data
N/A	Ramp Length (in)	64.0	Yes	BlendTrans Slope (%)	3.8
Yes	Ramp Width (in)	48.0	Yes	BlendTrans XSlope (%)	4.7
N/A	Flare Type LT	Sloped	N/A	Flare Type RT	Sloped
No	Flare Slope LT (%)	12.5	N/A	Flare Slope RT (%)	3.4
N/A	Flare Traversable LT?	Yes	N/A	Flare Traversable RT?	No
Yes	Landing Length (in)	83.0	Yes	DWS Provided?	Yes
Yes	Landing Width (in)	48.0	Yes	DWS Contrast?	Yes
Yes	Landing Slope (%)	0.8	Yes	DWS Length (in)	24.5
No	Landing X Slope (%)	5.2	Yes	DWS Full Width?	Yes
N/A	Landing Curb? (Y/N)	No	Yes	DWS Offset (in)	1.8
N/A	Shared Landing?	No			
Yes	Gutter Ponding?	No	No	Gutter Slope (%)	5.3
Yes	Gutter Lip Ht (in)	0.0	No	Gutter X Slope (%)	6.4
N/A	Painted X Walk1?	No	N/A	Painted X Walk2?	N/A
	X Walk 1 Direction	To NE		X Walk 2 Direction	N/A
	X Walk 1 Width (in)	N/A		X Walk 2 Width (in)	N/A
	X Walk 1 Slope (%)	4.7		X Walk 2 Slope (%)	N/A
	X Walk 1 X Slope (%)	7.2		X Walk 2 X Slope (%)	N/A

N/A	Ramp inside XWalk1?	N/A	N/A	Ramp inside XWalk2?	N/A
	Road Slope (%)	7.2		Clear Space?	Yes
	Road X Slope (%)	4.7	N/A	Clear Space to XWalk (in)	N/A
Yes	Any Obstructions?	No	Yes	Storm Grate/Utility Hazard?	No
	Obstruction Type		Į.	Storm Grate/Utility Type	
		N/A	ļ.		N/A
			Yes	Surface Condition? (G/P)	Good
			No	Curb Slope (%)	14.8

BRENTMOOR DR Street 1 Name Stop Condition-Street 1 None Street 2 Name N/A Stop Condition-Street 2 N/A Remove & Replace Curb Ramp With Two New Directional Ramps or Equivalent. Remove & Replace Gutter.

W// ND/ N.	
t Found, R304.5.3, R30 04.5.4	4.2.3,
