# Access Compliance Report

## Public Rights-of-Way

### (Curb Ramps)

Intersection ID: 23444	Main Street: TRAVELERS_CT	Cross Street: PROVIDENCE_LN_WEST	Location: W
ADA ID: 367C044E9E9C	Ramp Type: PerpDiag	Initial Pass/Fail: Fail	Overall Compliance: No
Severity Score: 21.25			
Codes/Mitigation Info/Possible Solution		Field Measurements/Component Compliance

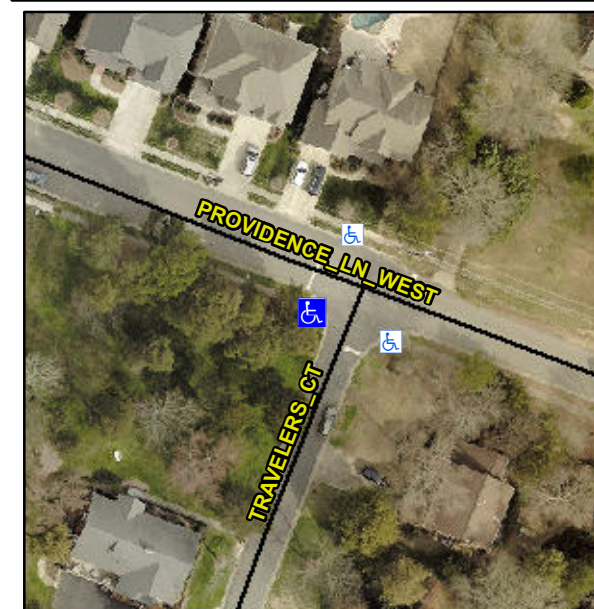
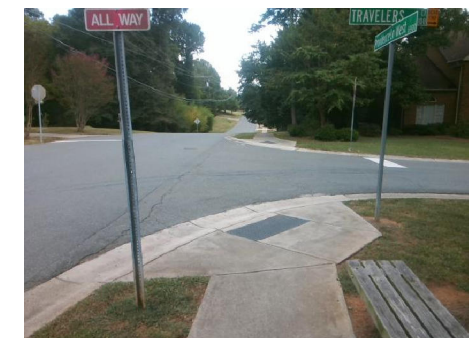
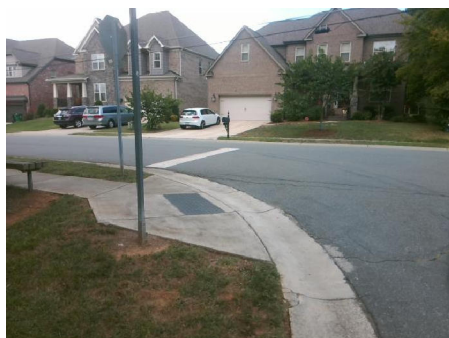
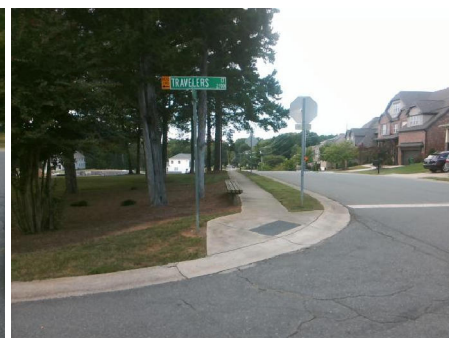
**Not Found, R304.5.1, R304.2.2**

Compliance	Description	Data	Compliance	Description	Data
N/A	Ramp Length (in)	73.0	No	Ramp Slope (%)	10.2
No	Ramp Width (in)	47.0	Yes	Ramp XSlope (%)	1.7
N/A	Flare Type LT	N/A	N/A	Flare Type RT	N/A
N/A	Flare Slope LT (%)	N/A	N/A	Flare Slope RT (%)	N/A
N/A	Flare Traversable LT?	N/A	N/A	Flare Traversable RT?	N/A
N/A	Landing Length (in)	N/A	N/A	DWS Provided?	N/A
N/A	Landing Width (in)	N/A	N/A	DWS Contrast?	N/A
N/A	Landing Slope (%)	N/A	N/A	DWS Length (in)	N/A
N/A	Landing X Slope (%)	N/A	N/A	DWS Full Width?	N/A
N/A	Landing Curb? (Y/N)	N/A	N/A	DWS Offset (in)	N/A
N/A	Shared Landing?	N/A			
N/A	Gutter Ponding?	N/A	N/A	Gutter Slope (%)	N/A
N/A	Gutter Lip Ht (in)	N/A	N/A	Gutter X Slope (%)	N/A
N/A	Painted X Walk1?	No	N/A	Painted X Walk2?	No
	X Walk 1 Direction	To SE		X Walk 2 Direction	To NE
N/A	X Walk 1 Width (in)	N/A	N/A	X Walk 2 Width (in)	N/A
	X Walk 1 Slope (%)	0.6		X Walk 2 Slope (%)	4.3
	X Walk 1 X Slope (%)	3.1		X Walk 2 X Slope (%)	0.3

N/A	Ramp inside XWalk1?	N/A	N/A	Ramp inside XWalk2?	N/A
	Road Slope (%)	2.5	N/A	Clear Space?	N/A
	Road X Slope (%)	5.9	N/A	Clear Space to XWalk (in)	N/A
N/A	Any Obstructions?	N/A	N/A	Storm Grate/Utility Hazard?	N/A
	Obstruction Type			Storm Grate/Utility Type	
		N/A			N/A
			Yes	Surface Condition? (G/P)	Good

**Remove & Replace Curb Ramp With Two New Directional Ramps or Equivalent.**
