Access Compliance Report

Public Rights-of-Way

(Curb Ramps)

Intersection ID: 20422	Main Street: W_ARROWWOOD_RD	Cross Street: S_TRYON_ST	Location: NE
ADA ID: 367F4345DB53	Ramp Type: Perp	Initial Pass/Fail: Fail	Overall Compliance: No
Severity Score: 12.5			
Codes/Mitigation Info/Possible Solution		Field Measurements/Component Compliance

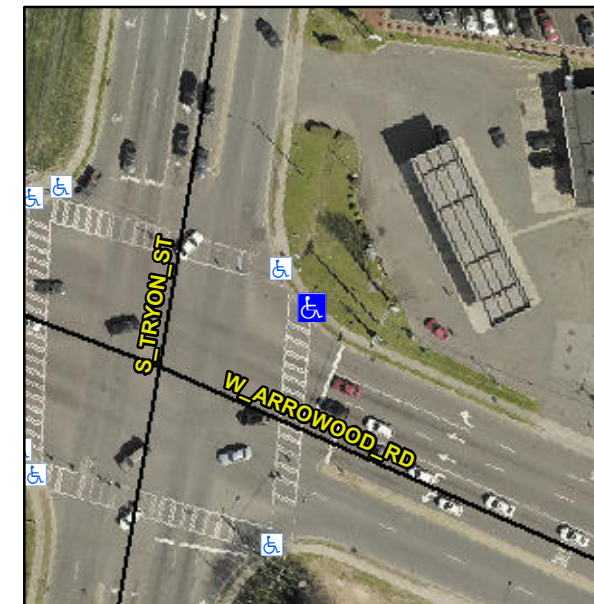
Not Found, R304.2.2

Compliance	Description	Data	Compliance	Description	Data
N/A	Ramp Length (in)	74.0	No	Ramp Slope (%)	9.4
Yes	Ramp Width (in)	50.0	Yes	Ramp XSlope (%)	1.5
N/A	Flare Type LT	N/A	N/A	Flare Type RT	N/A
N/A	Flare Slope LT (%)	N/A	N/A	Flare Slope RT (%)	N/A
N/A	Flare Traversable LT?	N/A	N/A	Flare Traversable RT?	N/A
N/A	Landing Length (in)	N/A	N/A	DWS Provided?	N/A
N/A	Landing Width (in)	N/A	N/A	DWS Contrast?	N/A
N/A	Landing Slope (%)	N/A	N/A	DWS Length (in)	N/A
N/A	Landing X Slope (%)	N/A	N/A	DWS Full Width?	N/A
N/A	Landing Curb? (Y/N)	N/A	N/A	DWS Offset (in)	N/A
N/A	Shared Landing?	N/A			
N/A	Gutter Ponding?	N/A	N/A	Gutter Slope (%)	N/A
N/A	Gutter Lip Ht (in)	N/A	N/A	Gutter X Slope (%)	N/A
N/A	Painted X Walk1?	Yes	N/A	Painted X Walk2?	N/A
	X Walk 1 Direction	To S		X Walk 2 Direction	N/A
N/A	X Walk 1 Width (in)	138.0	N/A	X Walk 2 Width (in)	N/A
	X Walk 1 Slope (%)	3.5		X Walk 2 Slope (%)	N/A
	X Walk 1 X Slope (%)	1.0		X Walk 2 X Slope (%)	N/A

N/A	Ramp inside XWalk1?	Yes	N/A	Ramp inside XWalk2?	N/A
	Road Slope (%)	N/A	N/A	Clear Space?	N/A
	Road X Slope (%)	N/A	N/A	Clear Space to XWalk (in)	N/A
N/A	Any Obstructions?	N/A	N/A	Storm Grate/Utility Hazard?	N/A
	Obstruction Type			Storm Grate/Utility Type	
		N/A			N/A
			Yes	Surface Condition? (G/P)	Good

Possible Solutions:

Remove & Replace Entire Ramp.

Total Cost: \$ 1850.00
