## Access Compliance Report Public Rights-of-Way (Curb Ramps)

Intersection ID: 10035712Main Street:REDDMAN\_RDCross Street:N/ALocation:NADA ID: 3687C137DD9BRamp Type:PerpInitial Pass/Fail:FailOverall Compliance:NoSeverity Score:37.5

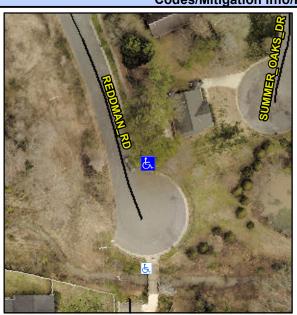
Field Measurements/Component Compliance						
Comp	liance Description	Data	Comp	liance	Description	Data
N/A	Ramp Length (in)	71.0	No	Ramp	Slope (%)	10.2
No	Ramp Width (in)	44.0	Yes	Ramp	XSlope (%)	4.5
N/A	Flare Type LT	N/A	N/A	Flare	Type RT	N/A
N/A	Flare Slope LT (%)	N/A	N/A	Flare	Slope RT (%)	N/A
N/A	Flare Traversable LT?	N/A	N/A	Flare	Traversable RT?	N/A
N/A	Landing Length (in)	N/A	N/A	DWS	Provided?	N/A
N/A	Landing Width (in)	N/A	N/A	DWS	Contrast?	N/A
N/A	Landing Slope (%)	N/A	N/A	DWS	Length (in)	N/A
N/A	Landing X Slope (%)	N/A	N/A	DWS	Full Width?	N/A
N/A	Landing Curb? (Y/N)	N/A	N/A	DWS	Offset (in)	N/A
N/A	Shared Landing?	N/A				
N/A	Gutter Ponding?	N/A	N/A	Gutte	r Slope (%)	N/A
N/A	Gutter Lip Ht (in)	N/A	N/A	Gutte	r X Slope (%)	N/A
N/A	Painted X Walk1?	No	N/A	Paint	ed X Walk2?	N/A
	X Walk 1 Direction	To S		X Wa	lk 2 Direction	N/A
N/A	X Walk 1 Width (in)	N/A	N/A	X Wa	lk 2 Width (in)	N/A
	X Walk 1 Slope (%)	5.0		X Wa	lk 2 Slope (%)	N/A

X Walk 1 X Slope (%)	5.0		X Wa	lk 2 X Slope (%)	N/A
N/A	Ramp inside XWalk1?	N/A	N/A	Ram	inside XWalk2?	N/A
	Road Slope (%)	N/A	N/A	Clear	Space?	N/A
	Road X Slope (%)	N/A	N/A	Clear	Space to XWalk (in)	N/A
N/A	Any Obstructions?	N/A	N/A	Storn	n Grate/Utility Hazard?	N/A
	Obstruction Type			Storn	n Grate/Utility Type	
		N/A				N/A
			No	Surfa	ce Condition? (G/P)	Poor

Possible Solutions:
Remove & Replace Entire Ramp.
·
Surveyor Notes:
N/A
DDOIN/AD A
PROW/ADA:
Not Found, R304.5.1, R304.2.2, R302.7
K302.7
