## Access Compliance Report Public Rights-of-Way (Curb Ramps)

Intersection ID: 51054 Main Street: MULBERRY\_CHURCH\_RD Cross Street: N/A Location: NE

ADA ID: 36AED2900462 Ramp Type: Perp Initial Pass/Fail: Fail Overall Compliance: No Severity Score: 8.75

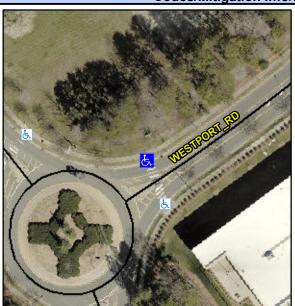
Not Found, R304.5.1

Compliance Description Data Compliance Description Data Yes N/A Ramp Length (in) 48.0 Ramp Slope (%) 5.0 Yes Ramp XSlope (%) No Ramp Width (in) 47.0 1.2 N/A N/A Flare Type LT N/A Flare Type RT N/A N/A N/A N/A Flare Slope RT (%) N/A Flare Slope LT (%) N/A Flare Traversable LT? N/A N/A Flare Traversable RT? N/A N/A N/A N/A DWS Provided? N/A Landing Length (in) N/A Landing Width (in) N/A N/A **DWS Contrast?** N/A N/A N/A N/A Landing Slope (%) DWS Length (in) N/A N/A Landing X Slope (%) N/A N/A DWS Full Width? N/A Landing Curb? (Y/N) N/A N/A DWS Offset (in) N/A N/A Shared Landing? **Gutter Ponding?** N/A N/A Gutter Slope (%) N/A Gutter Lip Ht (in) N/A N/A Gutter X Slope (%) N/A Painted X Walk1? Yes N/A Painted X Walk2? N/A X Walk 1 Direction To S X Walk 2 Direction N/A 119.0 N/A X Walk 2 Width (in) X Walk 1 Width (in) N/A X Walk 1 Slope (%) 0.3 X Walk 2 Slope (%) N/A X Walk 1 X Slope (%) 1.2 X Walk 2 X Slope (%) N/A N/A Ramp inside XWalk2? Ramp inside XWalk1? Yes N/A Road Slope (%) N/A N/A Clear Space? N/A N/A Road X Slope (%) N/A Clear Space to XWalk (in) N/A N/A Any Obstructions? N/A Storm Grate/Utility Hazard? N/A **Obstruction Type** Storm Grate/Utility Type N/A N/A Yes Surface Condition? (G/P) Good

Remove & Replace Entire Ramp.
